# NIMBUS II FLIGHT EVALUATION AND ENGINEERING REPORT, LAUNCH THROUGH ORBIT 5275

NIMBUS II FLIGHT EVALUATION AND  
ENGINEERING REPORT,  
LAUNCH THROUGH ORBIT 5275

By Joseph J. McNaney and Bennie A. Palmer  
General Electric Company

Ralph Shapiro  
Goddard Space Flight Center  
Greenbelt, Md.

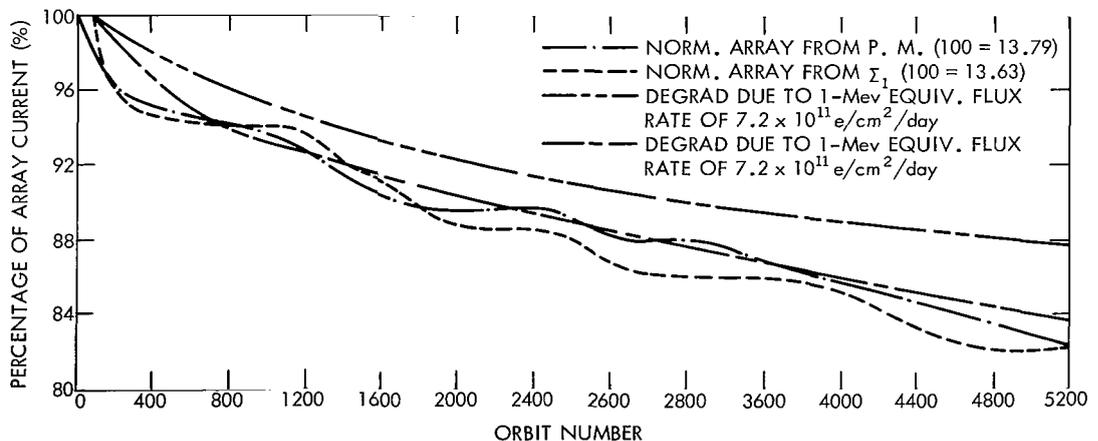
Figure 4-8—Degradation of normalized solar array.

Figure 4-8 is a time history of the normalized solar array average output indicating the degradation of the array. The normalized array output is shown for an estimated degradation caused by two levels of flux ( $7.2 \times 10^{11}$  and  $9.4 \times 10^{11}$  e/cm<sup>2</sup>/day).

The plot based on power management calculations indicates a large drop probably caused by ultraviolet degradation. Preflight expectations (Reference 3) were that the initial drop would level off at 4 percent after 100 hours (60 orbits). At orbit 100, the drop was approximately 2 percent and leveled off at 6 percent at orbit 500. The array output based on the summation-of-current methods indicated less than 1-percent drop in 200 orbits, followed by a sharp drop, again leveling off at approximately 6 percent at orbit 500. Thereafter, both techniques show the same trend. The significance of the irregular degradation pattern is uncertain; it may be caused by errors in

determining average array output, or it may be caused by short-term, cyclic variations in the flux rate or errors in normalizing for the board failures after orbit 1000. Two fixed corrections were used during the orbit when the failures occurred, although telemetry data indicated that, after the second array board failure, some output was still obtained from the board for some portion of the orbit. The loss of the PCM tape recorder in orbit 949 made a quantitative understanding of this phenomenon very difficult. Any intermittent output would therefore make the normalized array output plot be irregular and show high points. Refer to the paragraphs under Solar Cell Experiment for a description of the degradation of the two solar cell experiments.

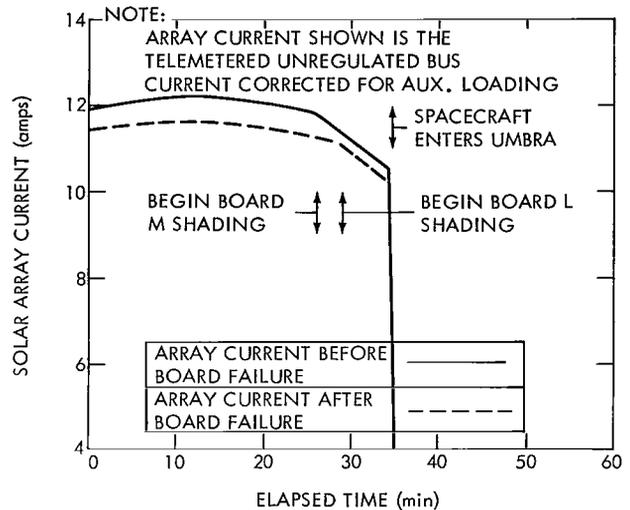
Figure 4-9—Shading effects on solar array output before and after paddleboard failure.

Between orbits 1065 and 1070, the solar array output dropped from a level of 12.5 to 11.9 amperes. Spacecraft attitudes were verified to be normal, and the solar array drive was operating properly. Paddleboards M and L, located on the left-hand paddle (the paddle on the left side of the spacecraft when one is looking along the velocity vector) are normally shaded by the sensory ring (with a positive  $\beta$  angle) before entering and after leaving the umbra. This condition was verified by a distinct pattern of decreased solar array output at these points in the orbit.

A comparison of the solar array current output trailoff (before entering the umbra) before and after the drop in total output is shown in Figure 4-9. From the figure it can be seen that the telemetered value of array current (after the board failure) averaged approximately 700-milliamperes lower before shading and approximately 0.2 amperes lower during maximum shading than it did before the failure. Assuming that all cells delivered the same amount of current, board L (with 980 cells) and board M (with 582 cells) would provide 1.04 amperes and 0.645 amperes, respectively, based on the telemetered array current value of 12.2 amperes (sensor reading plus auxiliary load losses). The decrease (approximately 600 milliamperes) compares favorably with the 645 milliamperes that would be provided by board M. From Figure 4-9 it is noted that, since the failure, shading does not affect the total output until approximately 5.5 minutes before entering the umbra, whereas before the failure it affected the output up to 3 minutes earlier. The reason for this is that board M, because of shading, is affected normally before board L (because of the manner in which the shading occurs; see Figure 4-10). Therefore, if board M has failed, the dropoff would be delayed (Figure 4-9).

The 200-milliampere difference during the period of maximum shading may be attributed to telemetry resolution of the unregulated bus sensor, which is approximately  $\pm 150$  milliamperes in the 10- to 12-ampere range. No voltage telemetry is available on either board M or board L; voltage telemetry on boards A, F, G, and J was normal.

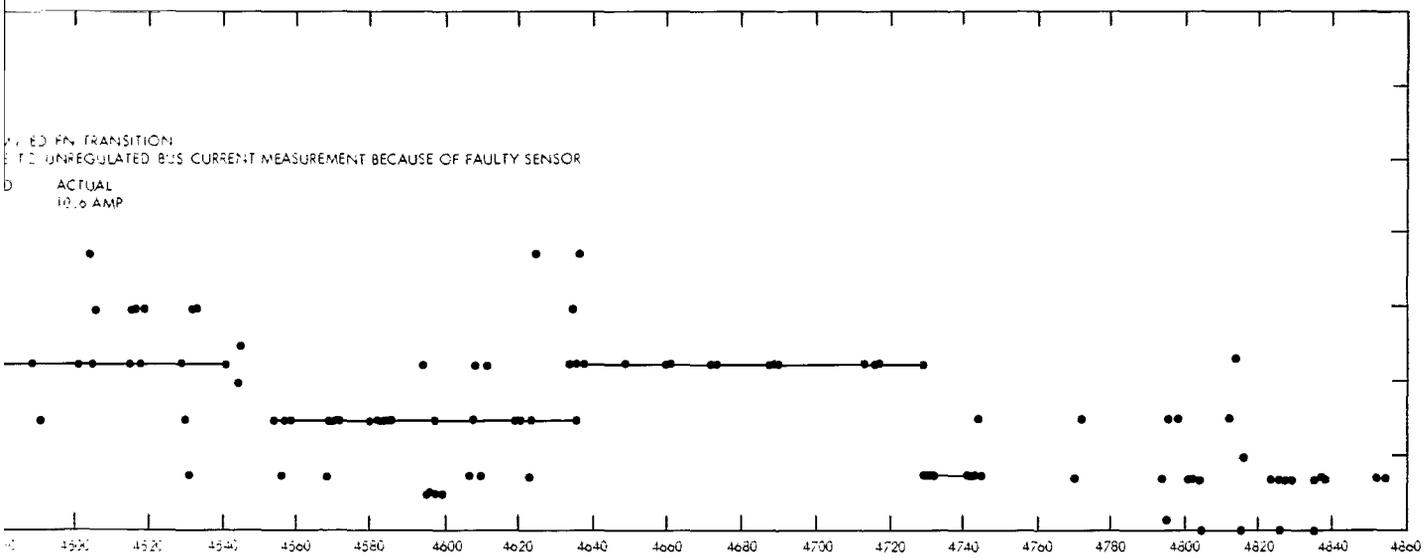
Figure 4-11—Unregulated bus history during second paddleboard failure.

The solar array output decreased by approximately 600 milliamperes between orbits 4384 and 4386. Figure 4-11 is a plot of the unregulated bus current before and after the decrease. The array output dropped approximately 1.00 ampere between orbits 4000 and 4700. During this interval, the output was expected to decrease 300 milliamperes because of a decrease in solar intensity and 100 milliamperes because of particle degradation (Reference 4). The resultant drop of approximately 600 milliamperes could not be localized because of telemetry constraints. Telemetered paddle voltages and temperatures were all normal.

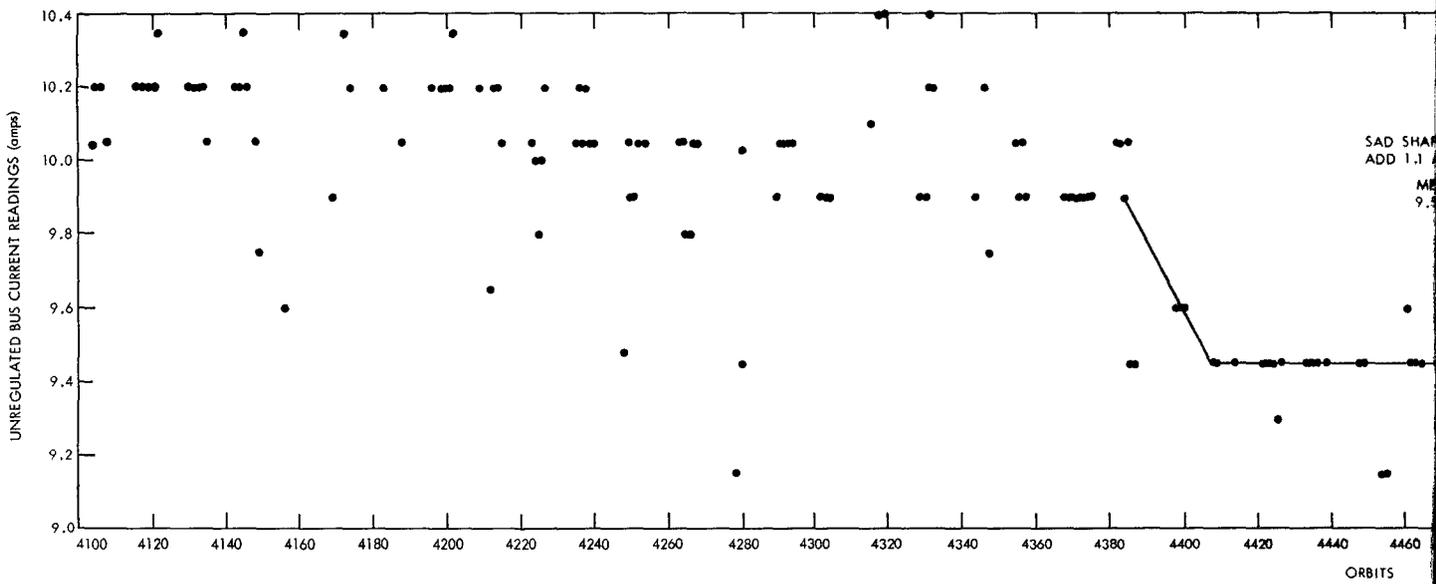
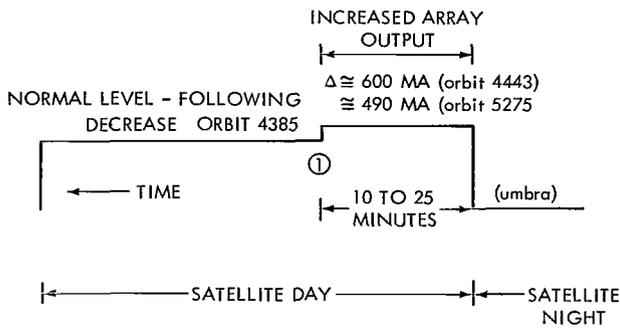
Figure 4-12—Increased array output following transition from satellite night to satellite day.

Related to the decrease in orbit 4386 is the increased array output noted after the exit from umbra. This did not occur until after the decrease of orbit 4385 and is still present. The drop (Figure 4-12) to the normal value, established after orbit 4385, usually occurred: (1) with paddle temperature between 7°C and 23°C; (2) with solar array shaft position between 10 and 30 degrees; and (3) with the spacecraft within ±10 minutes of the earth night-to-day transition. The initial magnitude of the increase was approximately 600 milliamperes (orbit 4443) and is presently approximately 490 milliamperes (orbit 5275). Examination of available telemetry has revealed no additional information. The most probable cause is thermal cycling of the associated panel board failure in orbit 4385.

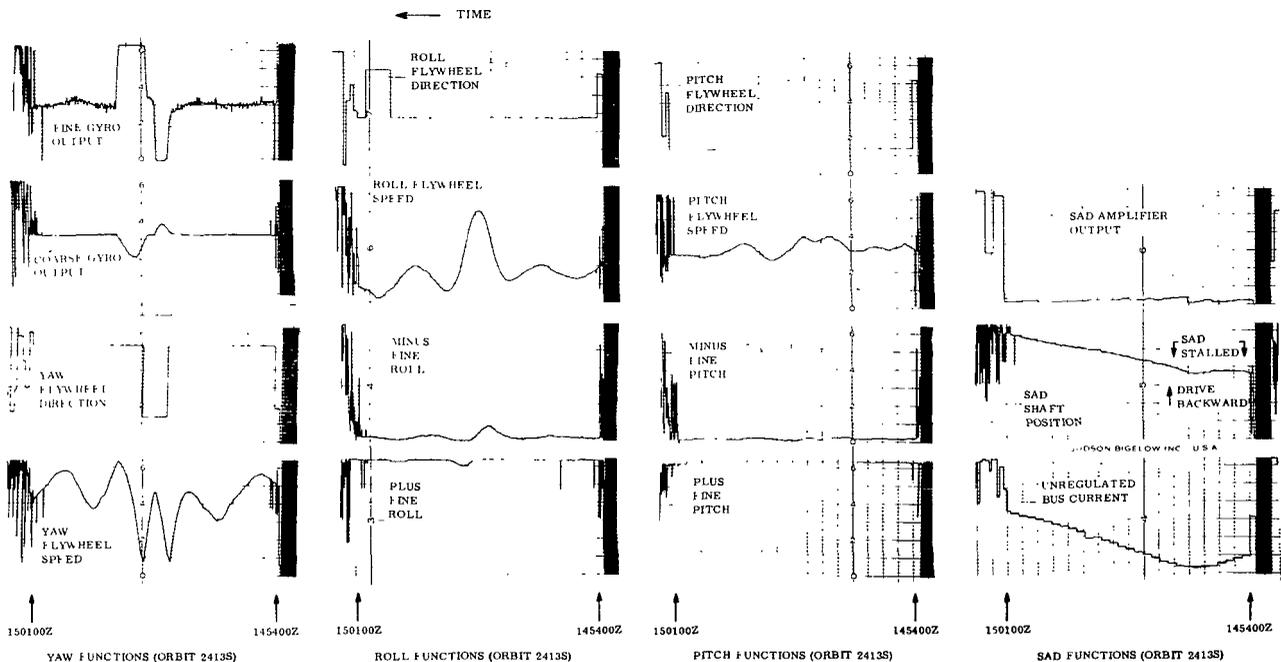
Figure 5-18—Control function performance during eclipse (orbit 2413S).

At 1458Z, the spacecraft underwent a severe perturbation lasting almost 2 minutes. This disturbance is shown by the fine gyro off-scale readings and the increased activity of the roll and yaw

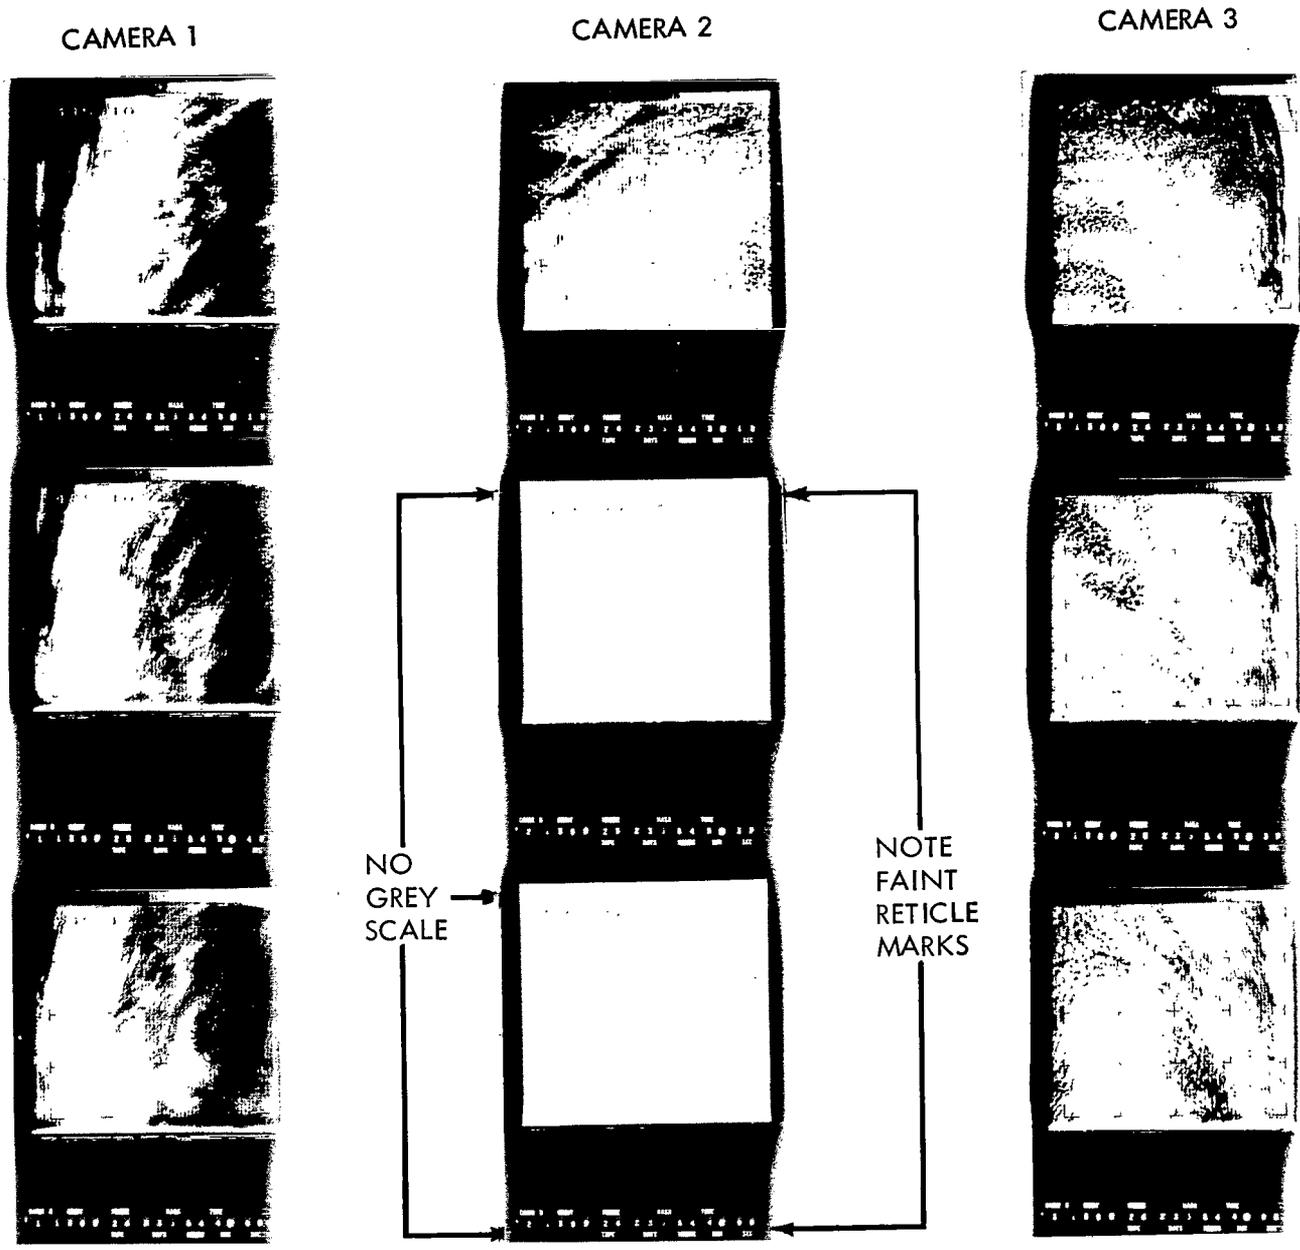
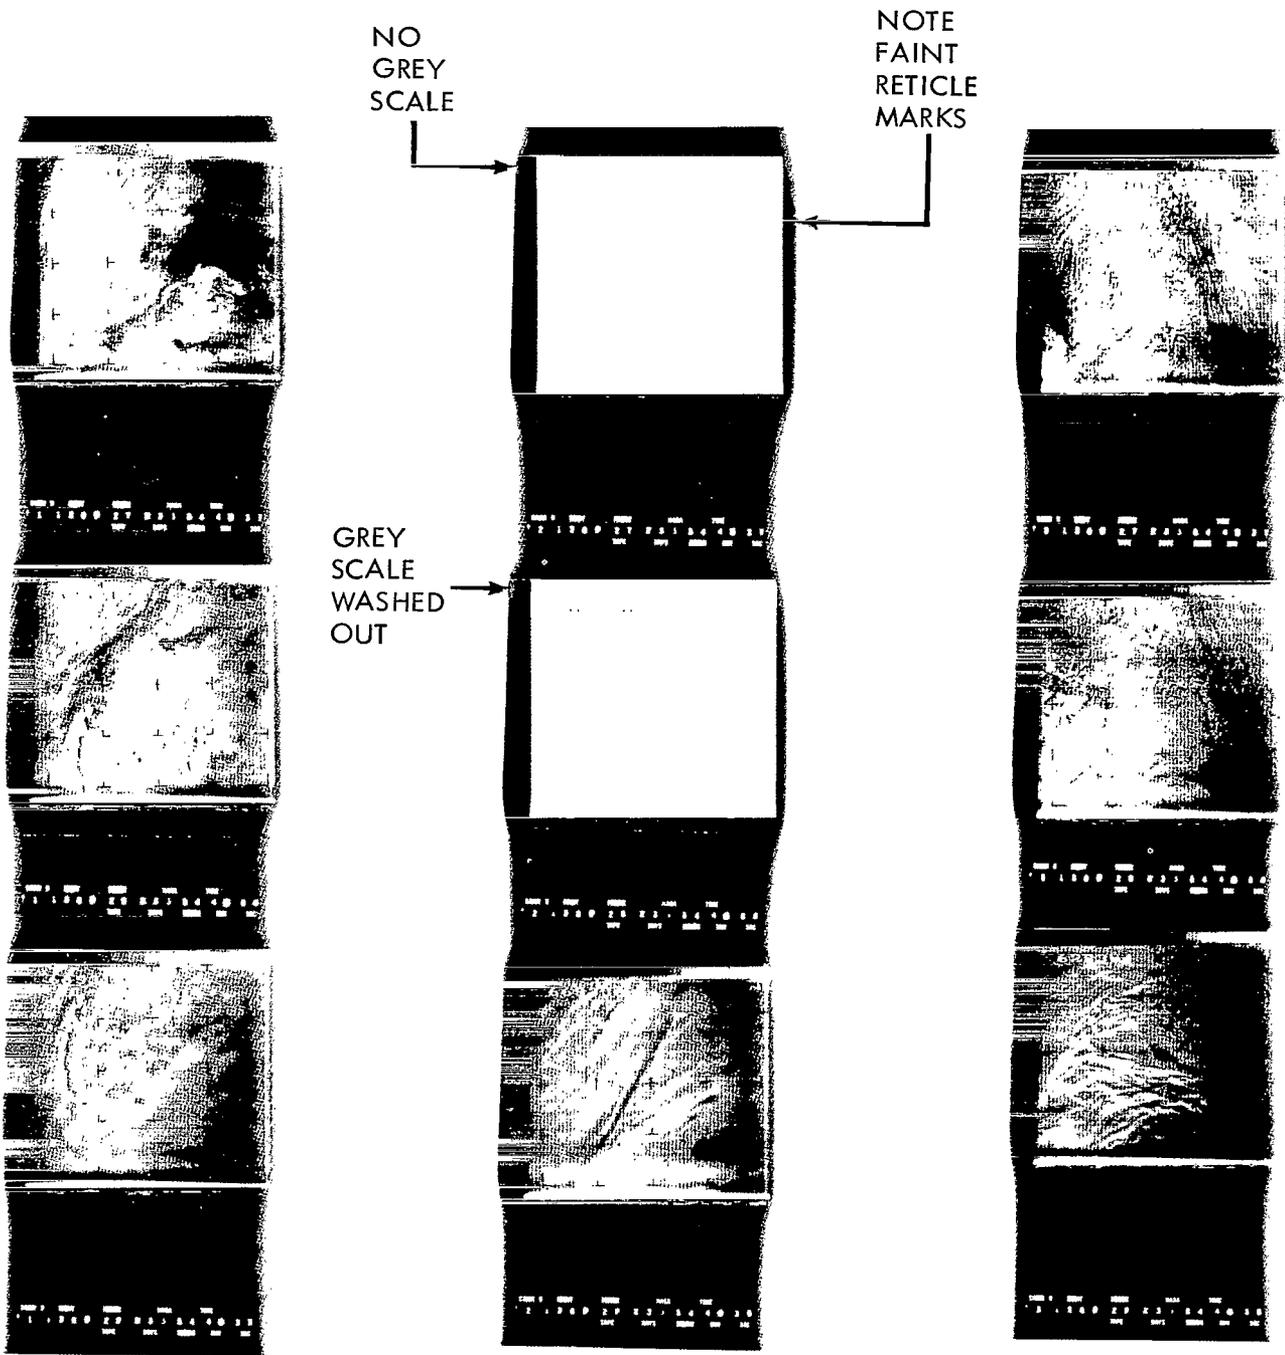
Figure 9-5— AVCS photographs showing washedout frames of camera no.2.

Figure 9-5 ( continued ) — AVCS photographs showing washedout frames of camera no.2.

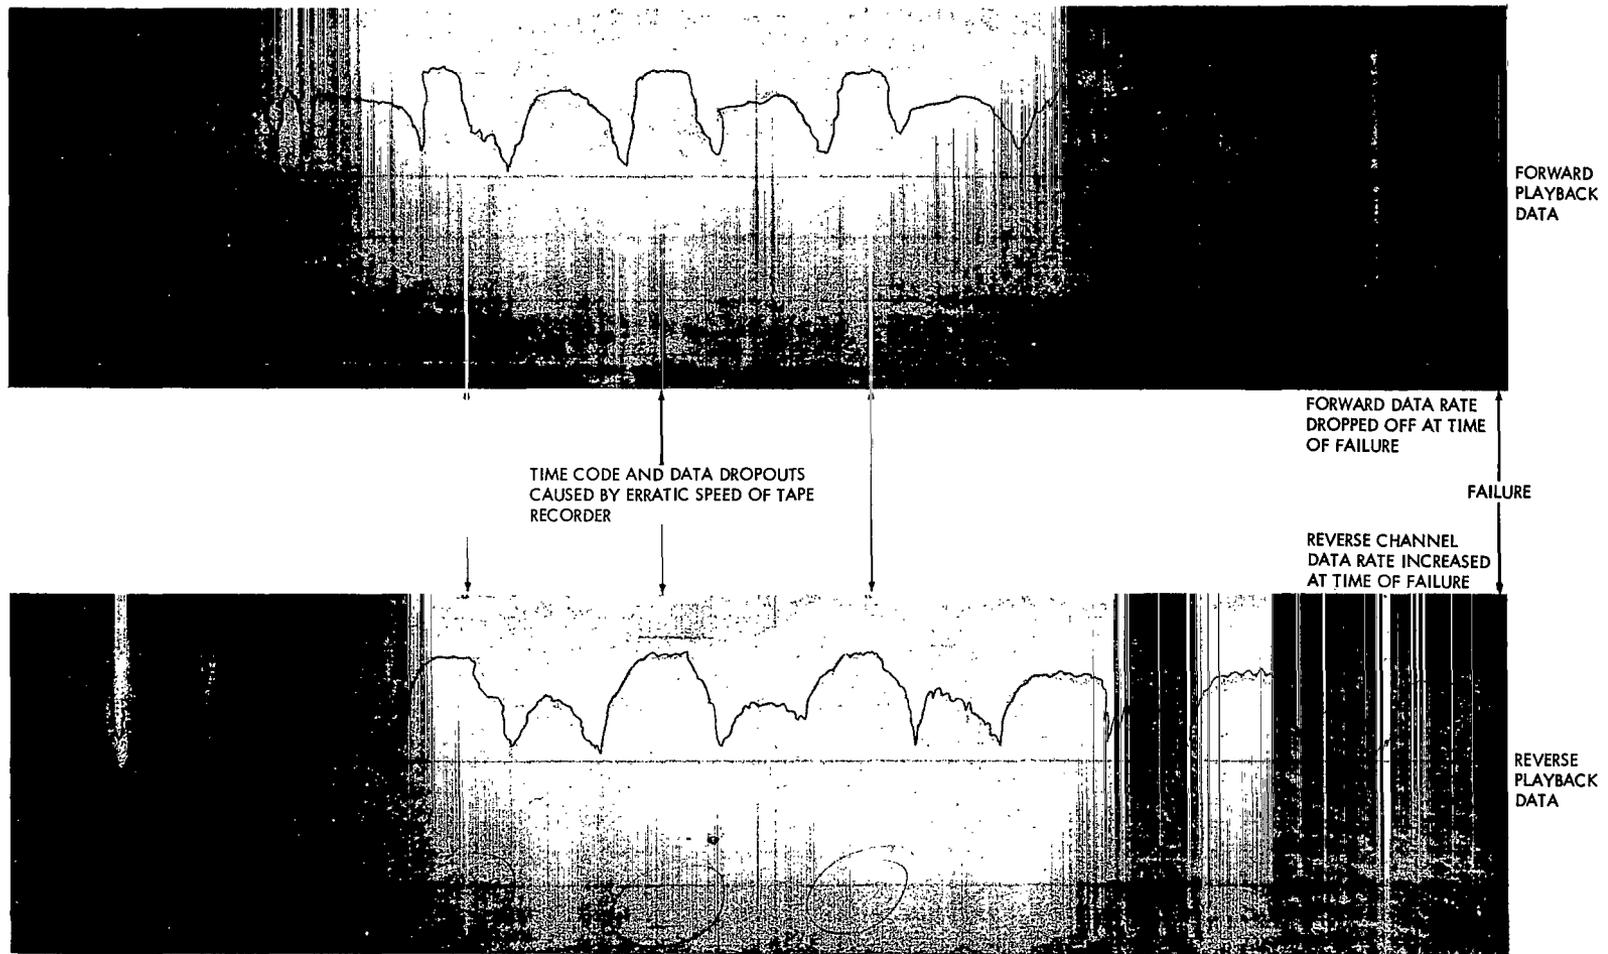
Figure 11-6—Visicorder presentation of HRIR recorder failure data (orbit 2455).

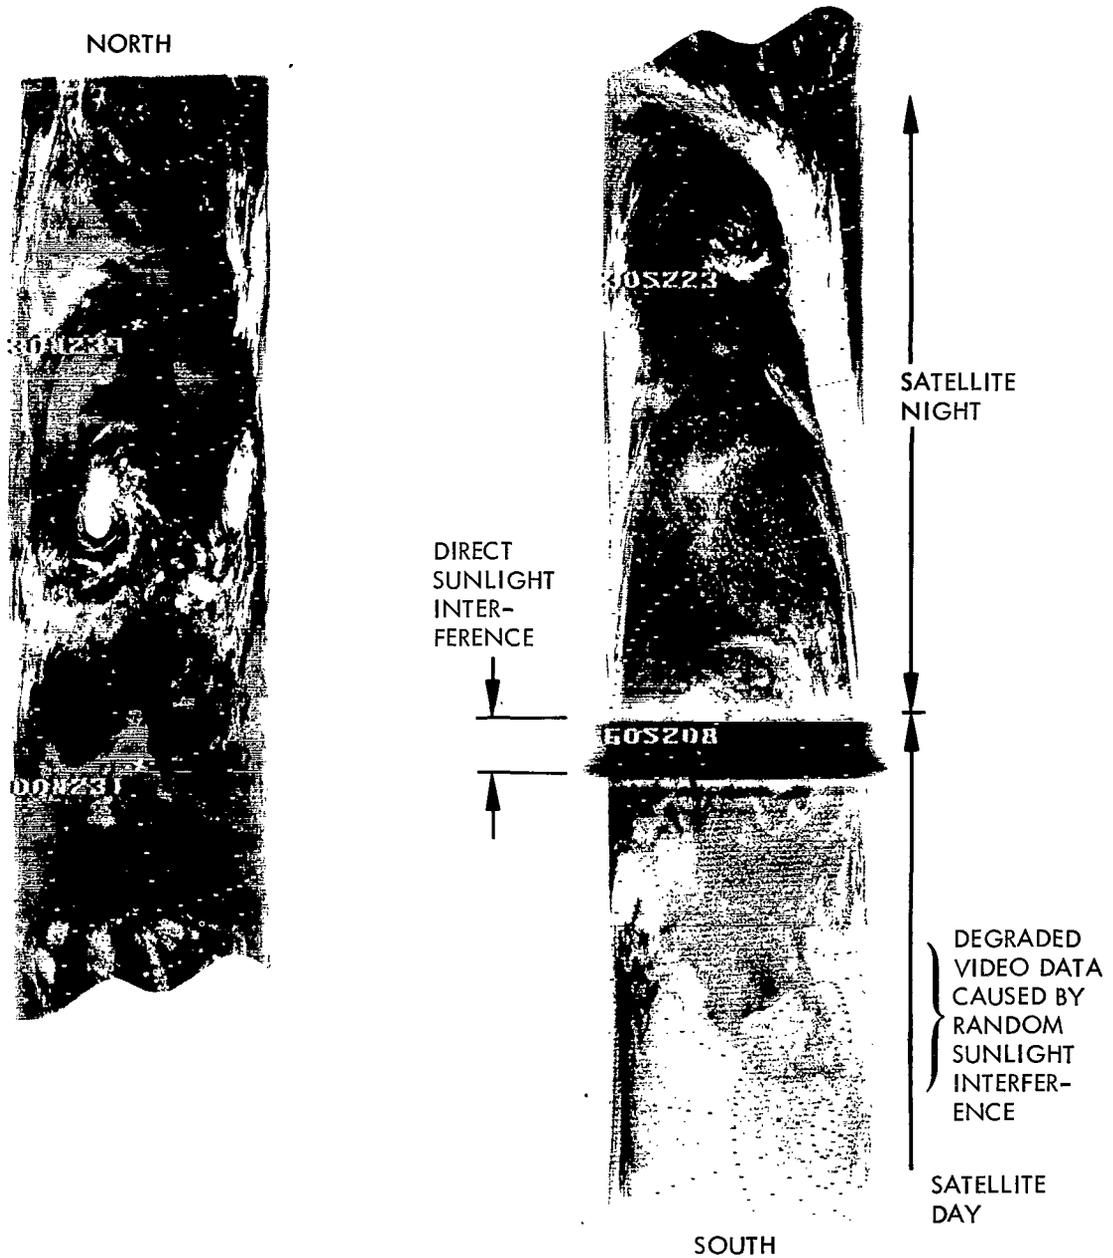
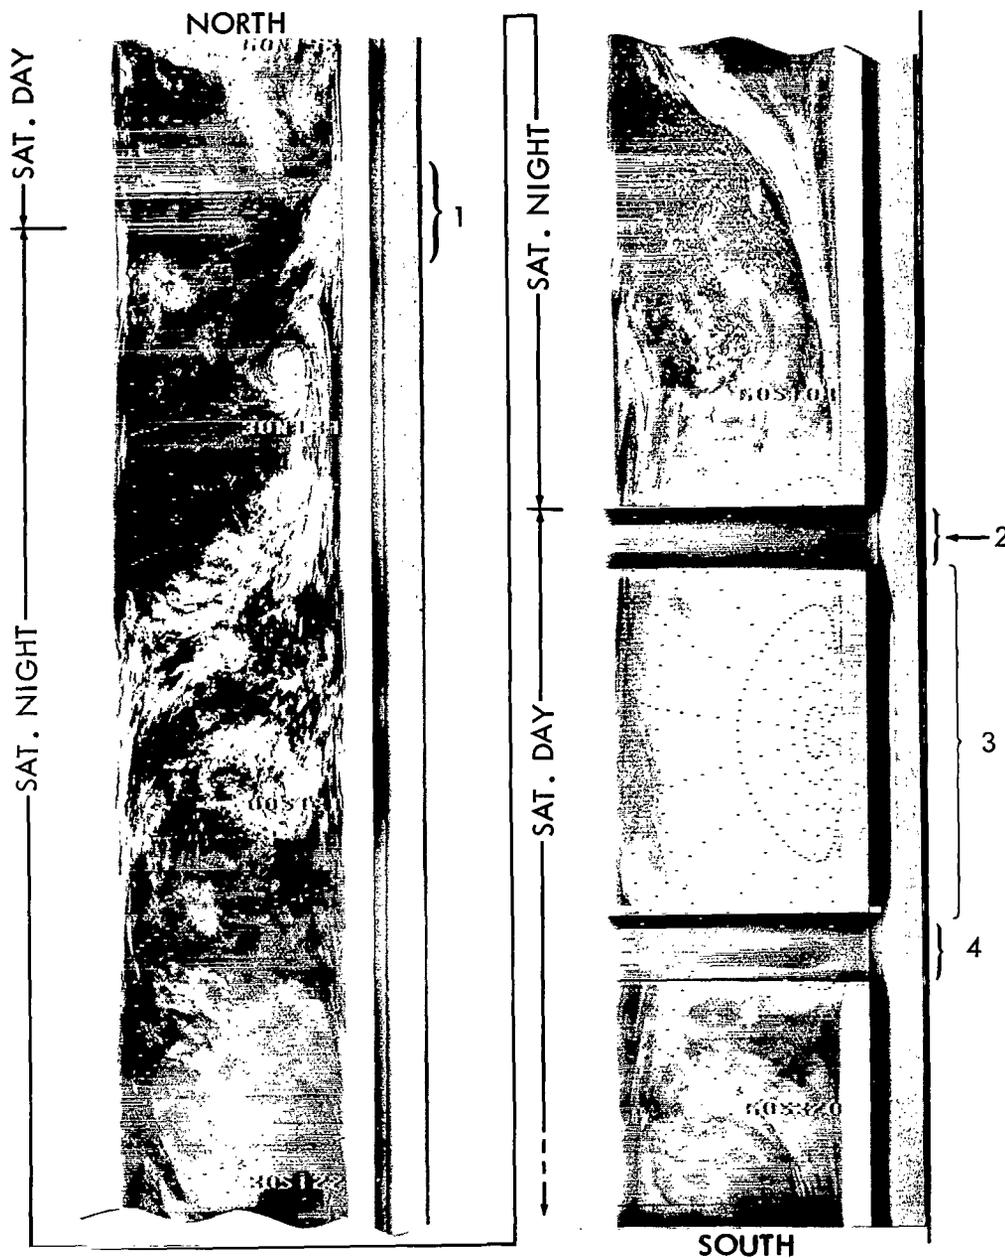
Figure 11-12—HRIR video data showing degradation caused by incident solar radiation.

1. REFLECTED SUNLIGHT INPUT AT SATELLITE DAY-TO-NIGHT TRANSITION
2. DIRECT SUNLIGHT INPUT AT SATELLITE NIGHT-TO-DAY TRANSITION

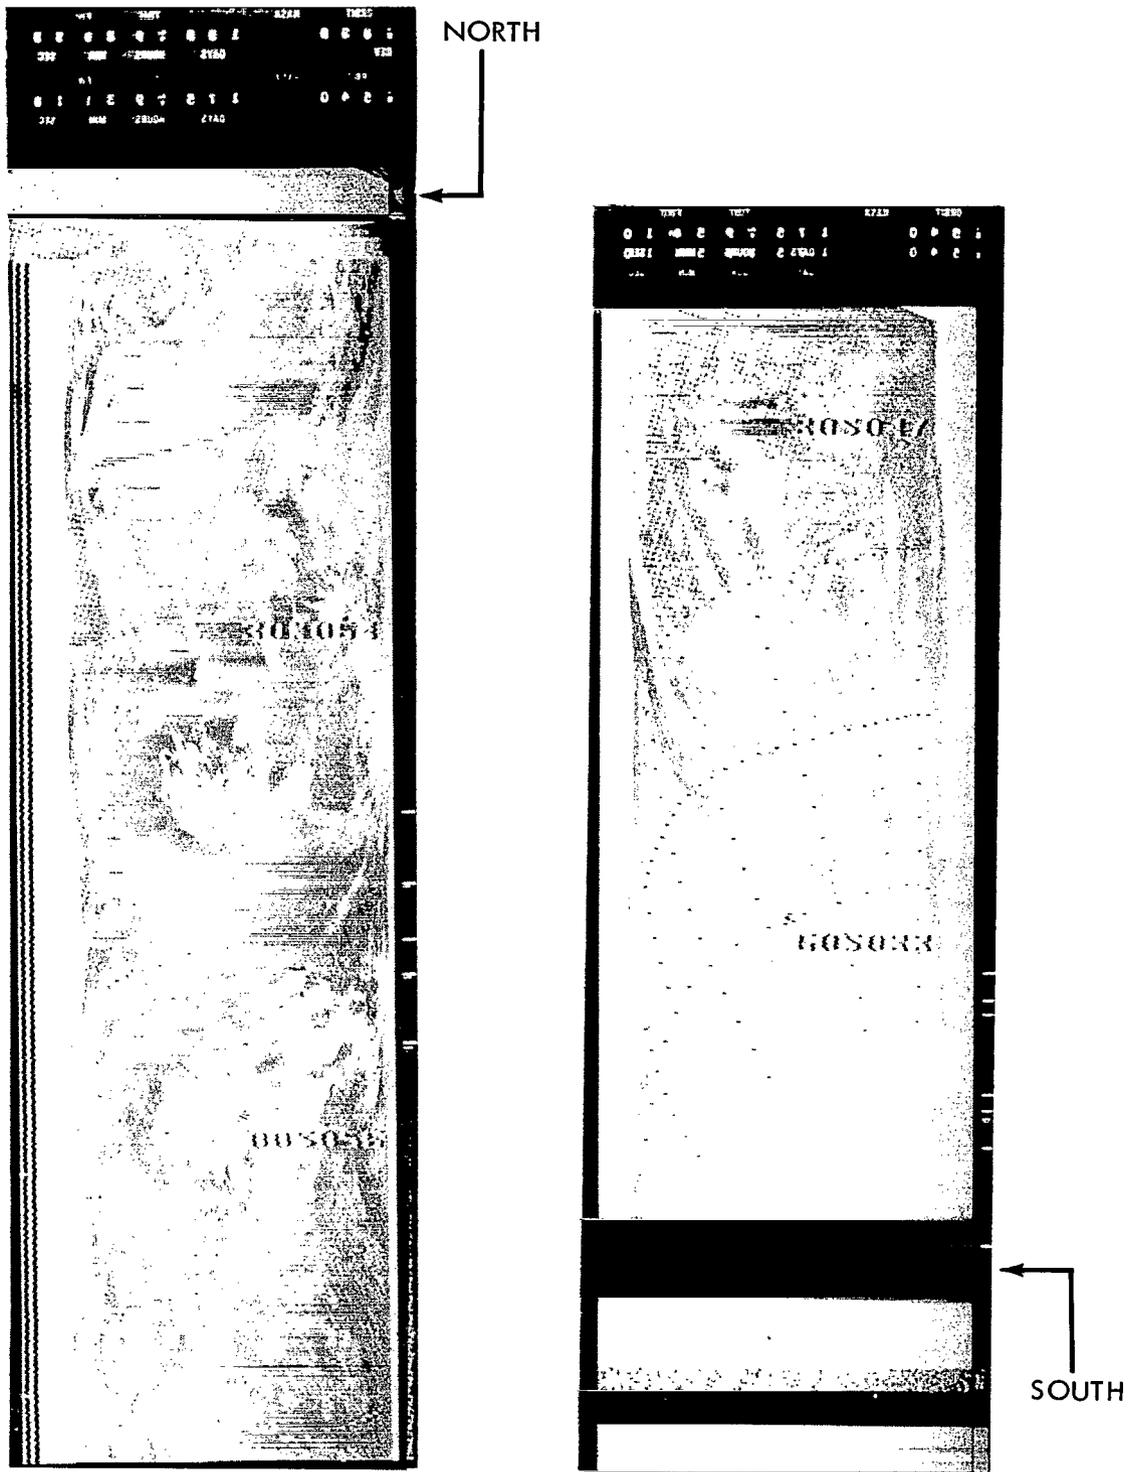
Figure 11-14— HRIR video data showing degradation of signal-to-noise ratio caused by elevated detector cell temperature (South Pole vicinity, orbit 5400).

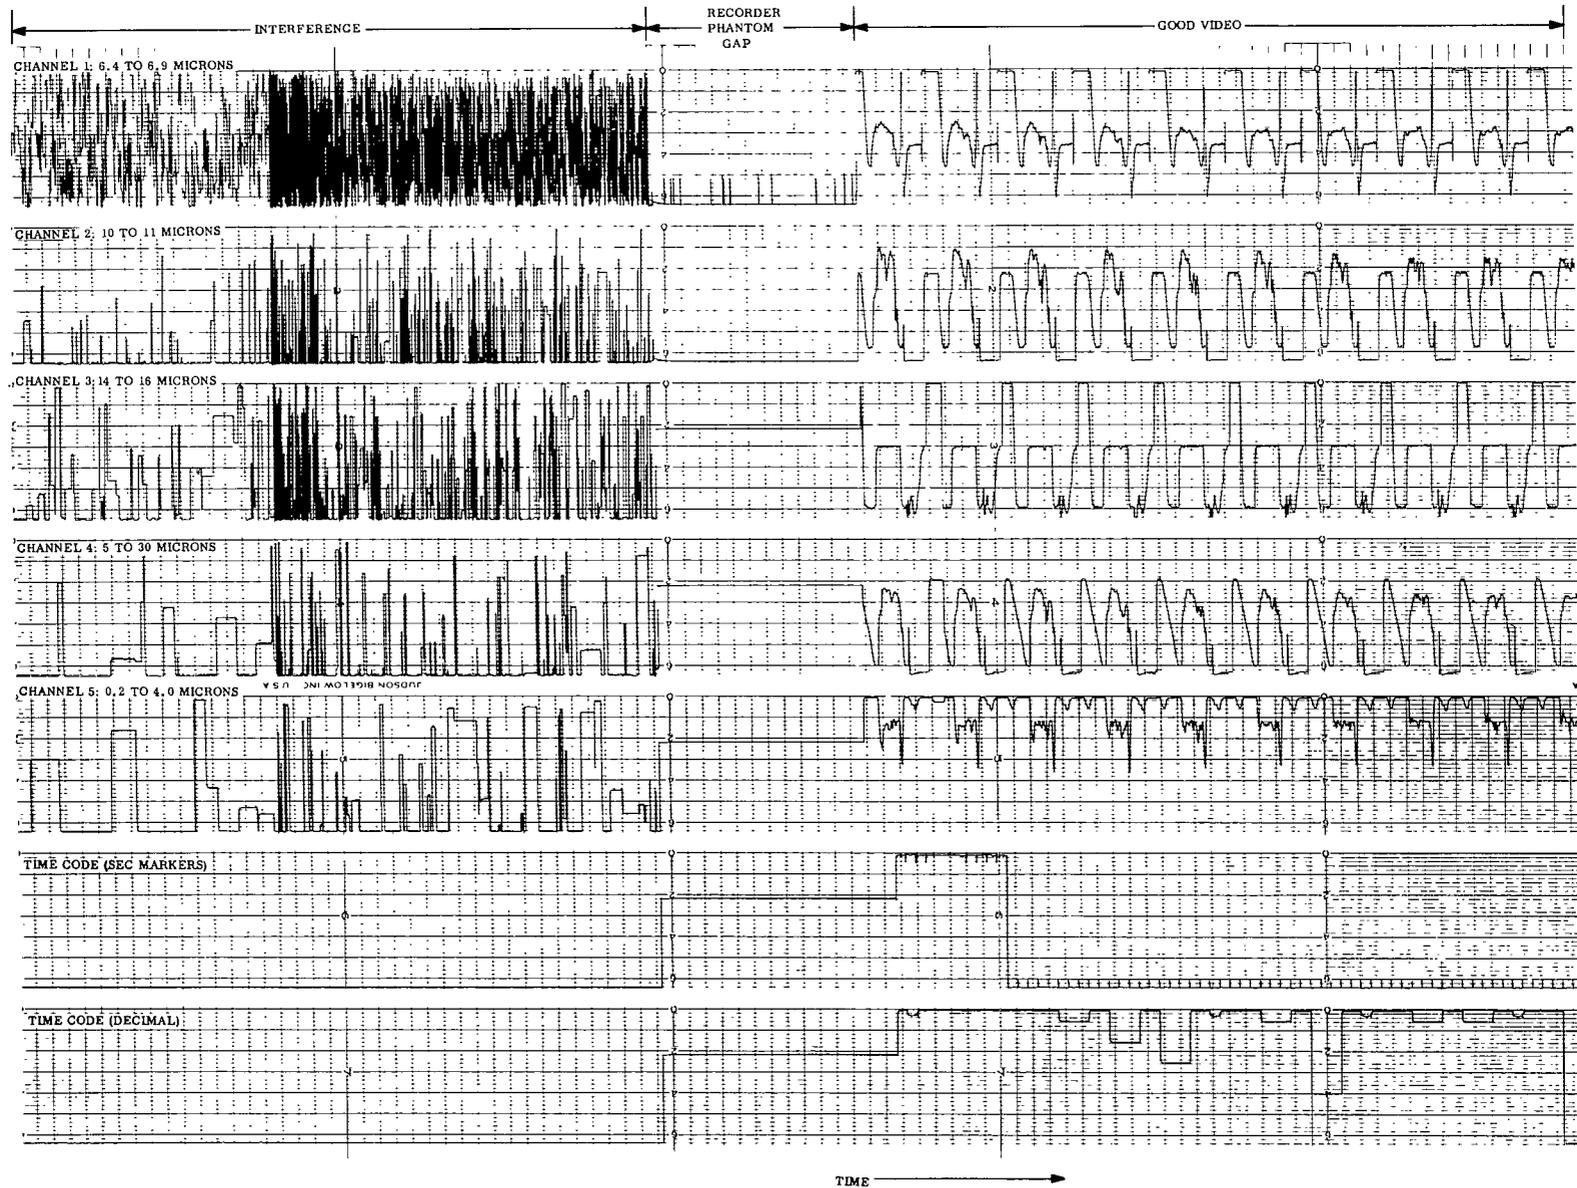
Figure 12-4—MRIR video brush recording showing APT subsystem interference at ground-station receiver.
