# NIMBUS II FLIGHT EVALUATION AND ENGINEERING REPORT, LAUNCH THROUGH ORBIT 5275

NIMBUS II FLIGHT EVALUATION AND  
ENGINEERING REPORT,  
LAUNCH THROUGH ORBIT 5275

By Joseph J. McNaney and Bennie A. Palmer  
General Electric Company

Ralph Shapiro  
Goddard Space Flight Center  
Greenbelt, Md.

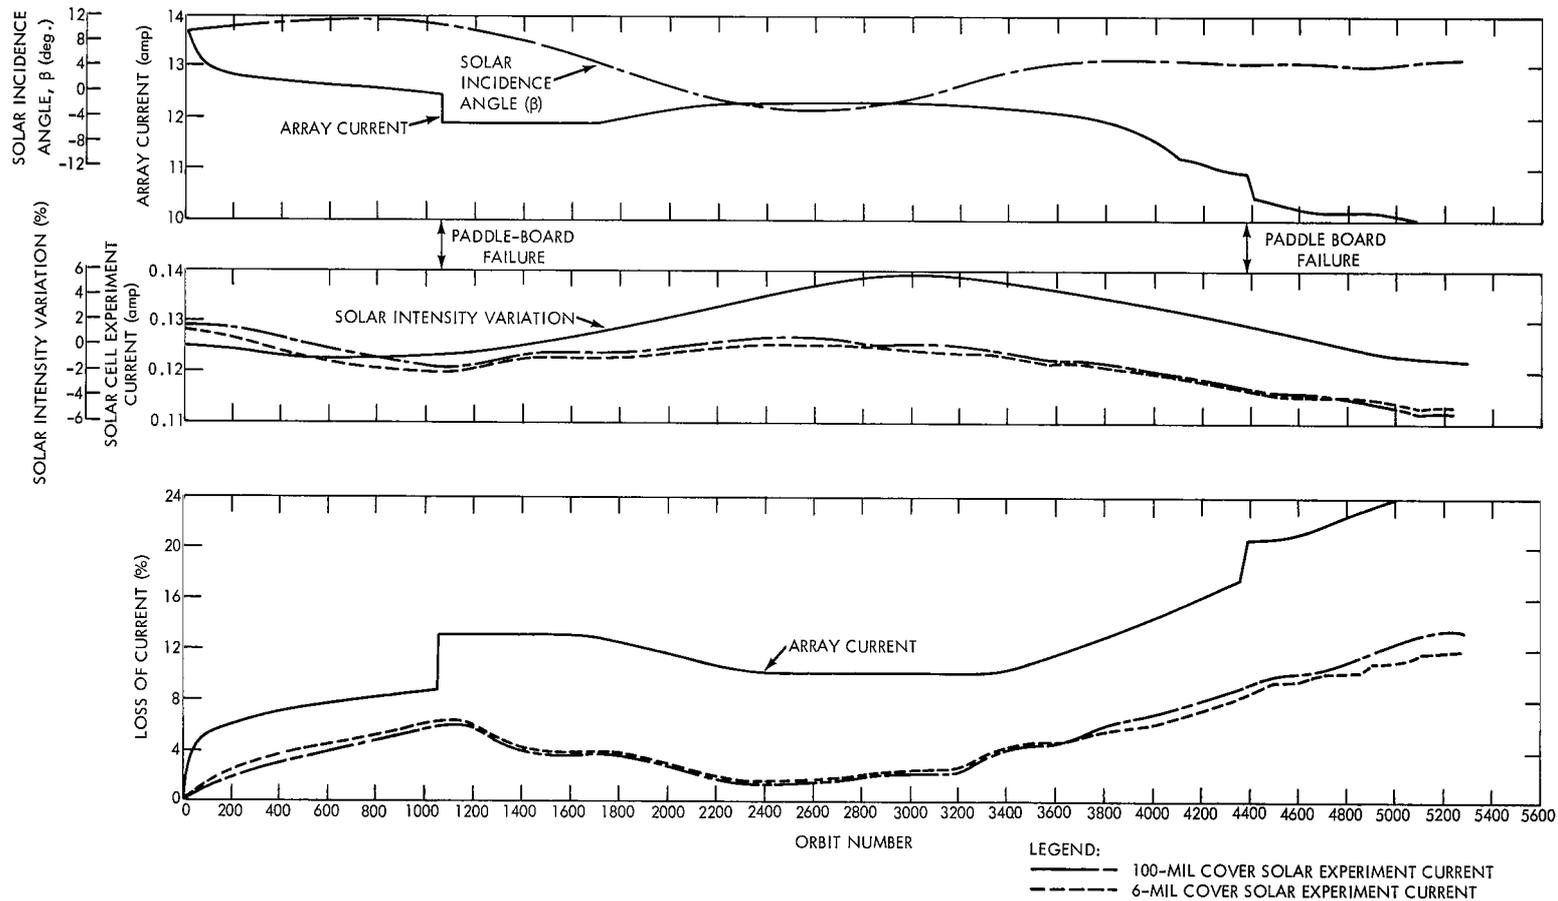
Figure 4-2—Array and solar-cell experiment current history.

During the early months of flight, the 9.75-degree solar incidence angle resulting from the spacecraft being launched early in the window (see Figure 4-2) caused the Controls Subsystem to shade a corner of one paddle before entering and after leaving the umbra. This caused a 1.4-ampere decrease in array output for 3 to 8 minutes.

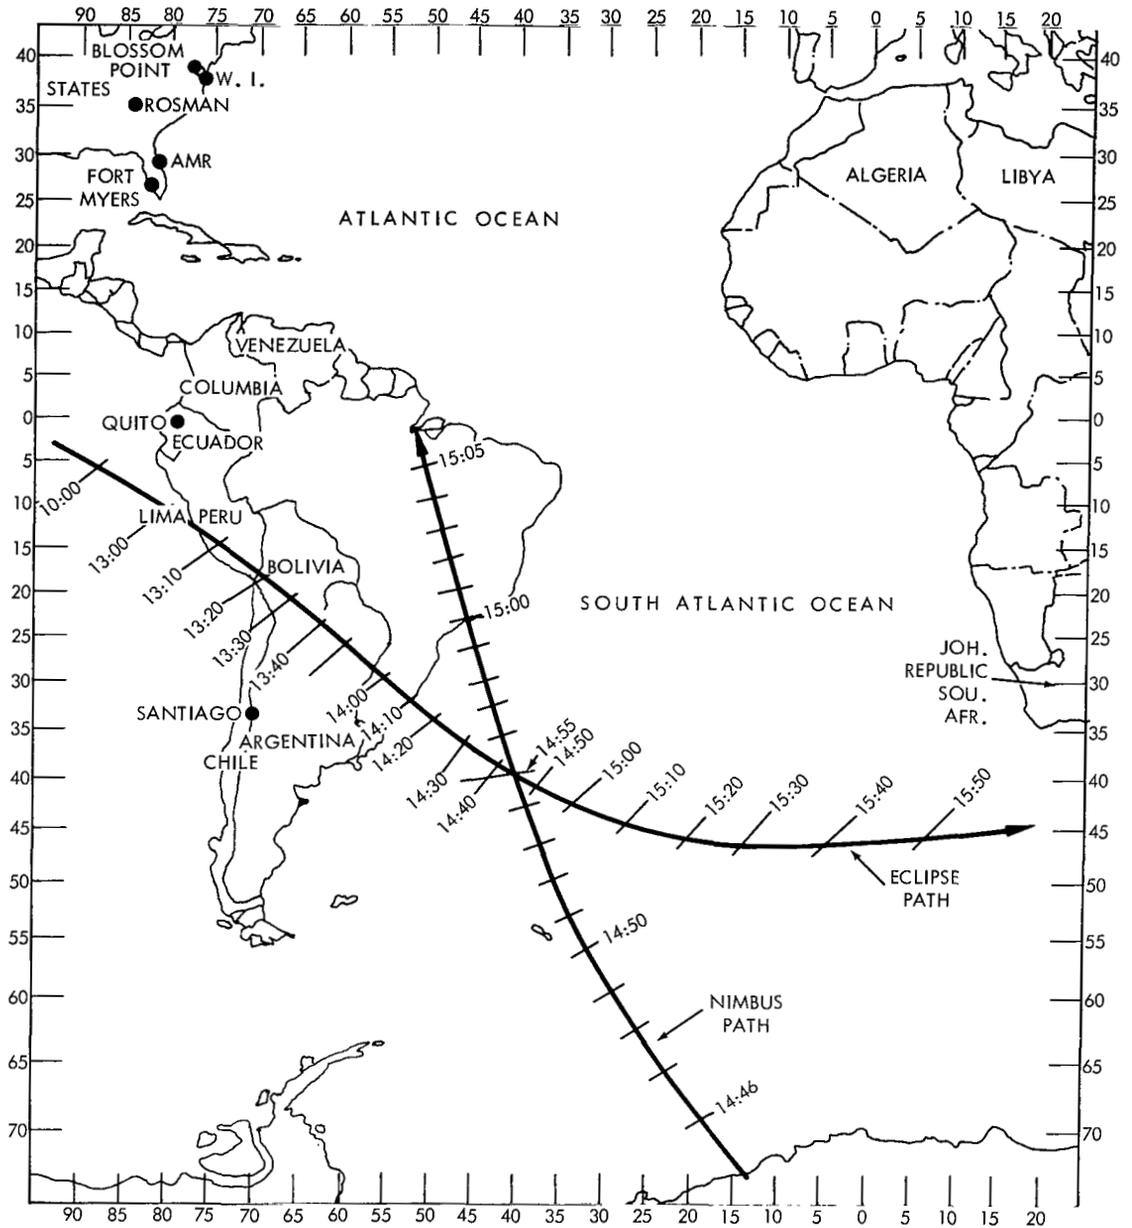
Figure 4-3—Intersection of Nimbus II orbit and path of solar eclipse (orbit 2413).

The spacecraft passed through three solar eclipses that affected the solar array output. The array output dropped approximately 2 amperes during orbits 68 and 4784, and during orbit 2413 (Figures 4-3 and 4-4), the array output dropped to zero for approximately 80 seconds. Paddle temperature dropped 10°C, and the unregulated bus voltage dropped from 30.4 to 26.5 volts, although there was sufficient sunlight on the paddle shaft sun sensors to prevent the paddles from being driven to the nighttime rest position (see Figure 5-19).

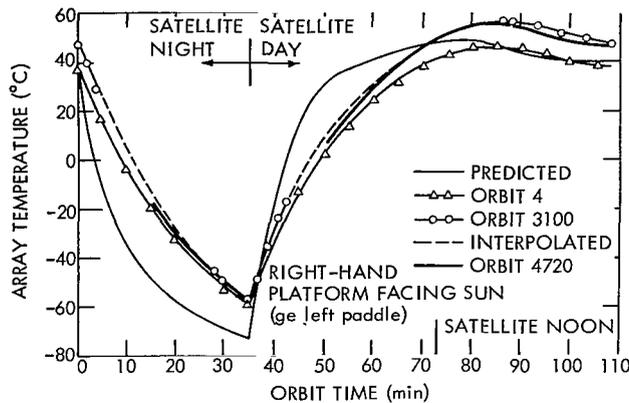
Figure 4-7—Solar platform temperature/time profile.

Figure 4-7 is a plot of the right-hand paddle (the paddle on the right facing the sun and in the velocity vector direction) orbital temperature profile for several orbits compared to the predicted values. The temperature remained relatively constant during the initial 1000 orbits and then increased with the increase in solar intensity, which peaked about orbit 3100 (6 percent higher). By orbit 4720, the paddle temperature only decreased a few degrees from the peak value at orbit 3100,

with the same sun intensity at launch. The decrease in solar conversion efficiency (down approximately 18 percent since launch) and a coating degradation contributed to the higher temperatures. The left-hand paddle exhibited the same profile except that the maximum temperature indicated is 10°C lower. A telemetry error is suspected and will be discussed later.

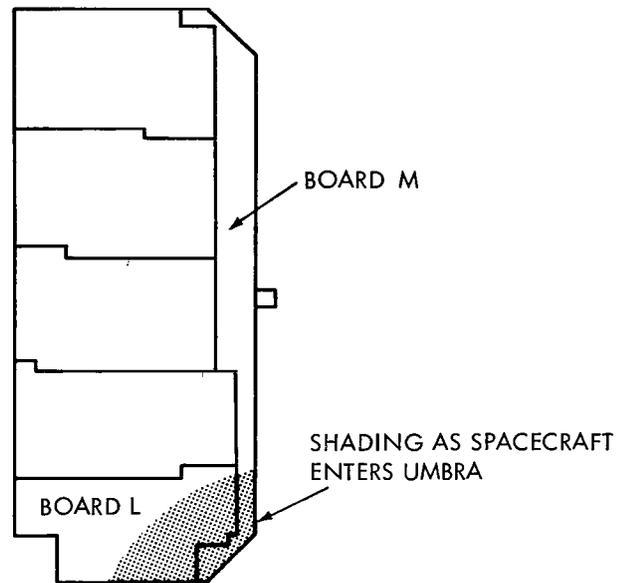
Figure 4-10—Shading of spacecraft left array (orbit 212U) during transition from satellite day to night.

A comparison of the solar array current output trailoff (before entering the umbra) before and after the drop in total output is shown in Figure 4-9. From the figure it can be seen that the telemetered value of array current (after the board failure) averaged approximately 700-milliamperes lower before shading and approximately 0.2 amperes lower during maximum shading than it did before the failure. Assuming that all cells delivered the same amount of current, board L (with 980 cells) and board M (with 582 cells) would provide 1.04 amperes and 0.645 amperes, respectively, based on the telemetered array current value of 12.2 amperes (sensor reading plus auxiliary load losses). The decrease (approximately 600 milliamperes) compares favorably with the 645 milliamperes that would be provided by board M. From Figure 4-9 it is noted that, since the failure, shading does not affect the total output until approximately 5.5 minutes before entering the umbra, whereas before the failure it affected the output up to 3 minutes earlier. The reason for this is that board M, because of shading, is affected normally before board L (because of the manner in which the shading occurs; see Figure 4-10). Therefore, if board M has failed, the dropoff would be delayed (Figure 4-9).

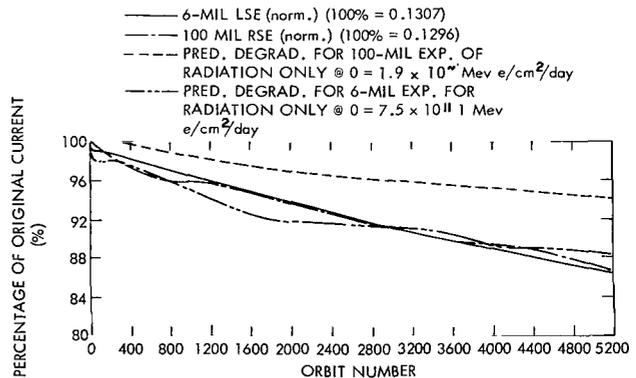
Figure 4-24—Current loss versus orbit for solar-cell experiments.

Figure 4-24 is a plot of the normalized percentage of current loss versus orbit for both experiments. The data points for these plots were taken at the same paddle position at all times. This permitted normalizing for sun angle and sun intensity seasonal variations, but introduced a possible error caused by temperature variations at that paddle position, ranging from 16° to 20° C.

Both experiments, in the early orbits, showed a smaller loss caused by ultraviolet damage than the solar array indicated. The degradation at orbit 5200 was near the predicted

value at a flux level of  $7.5 \times 10^{11}$  e/cm<sup>2</sup>/day (3 to 4 percent for first 100 hours predicted) predicted for the 6-mil experiment, which has the same characteristics as the actual array cells. The 100-mil experiment had a much higher degradation than anticipated. The extra thick coverglass on this experiment yielded a calculated flux rate of  $1.9 \times 10^{11}$  e/cm<sup>2</sup>/day on the actual cell. A 4-percent degradation was predicted at orbit 3100, yet 10 percent was actually observed.

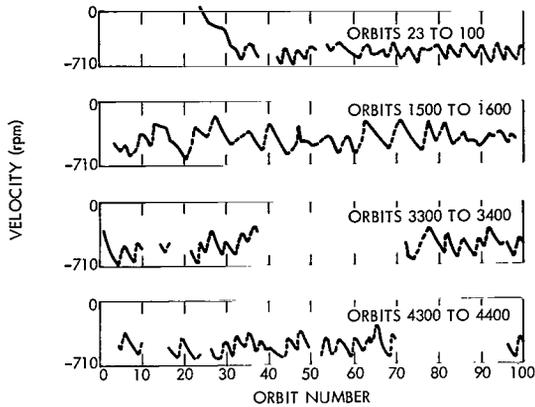
Figure 5-9—Pitch velocity profile.

Since orbit 13, a nearly constant negative pitch disturbance torque caused the pitch flywheel to absorb momentum continuously. Each third or fourth orbit, as the pitch flywheel speed approached -900 rpm, the torque caused by accelerating the solar array to the maximum slew rate (upon entering the earth's umbra) induced a negative pitch error that, in turn, caused the flywheel to attain gating speed. Following the solenoid gate, the flywheel speed was reduced to approximately -400 rpm, thus beginning the momentum buildup cycle again (Figure 5-9). Occasionally, the flywheel did

the flywheel speed was  $-800$  rpm at the initiation of the disturbance, the  $-200$  rpm additionally required to control the disturbance was sufficient to cause the positive solenoid to gate. This gate reinforced the rate induced by the flywheel and caused an overshoot of the fine limit cycle deadbands in the positive direction. Approximately 1 minute was required to regain pitch fine limit cycle control. Before orbit 21, when the pitch flywheel was maintaining a positive momentum vector, the pitch error (induced by the acceleration of the SAD to the maximum satellite night slew rate) did not exceed the fine limit cycle deadbands at any time during these transition periods.

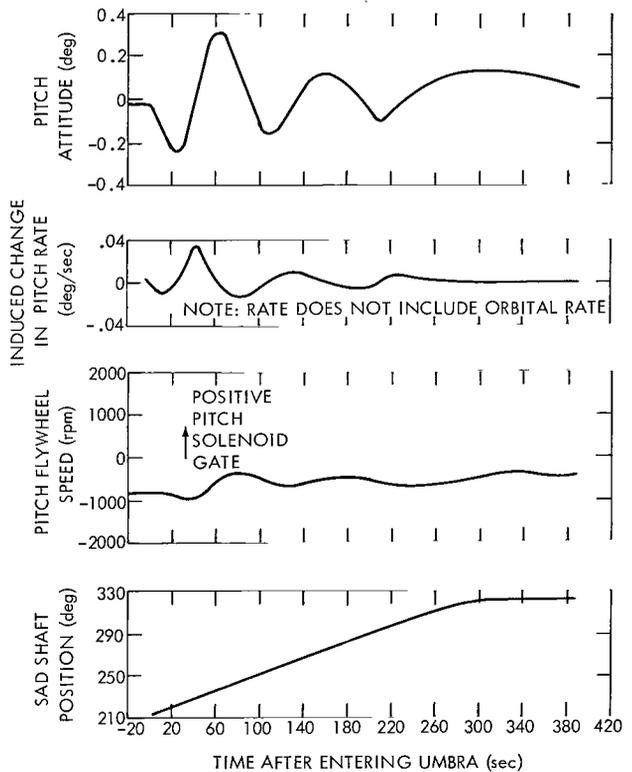
Figure 5-10—Pitch stabilization control characteristics during transition from satellite day to satellite night (orbit 1220).

The pitch disturbance that occurred during the satellite day-to-night transition period is illustrated in Figure 5-10. This figure shows that the pitch flywheel was capable of overcoming the negative pitch error. However, since

torqued the spacecraft in a positive sense that, combined with array deceleration, caused an overshoot of approximately 0.24 degree beyond the initial attitude of 0.2 degree. The perturbation was subsequently damped, and the pitch attitude returned to its initial condition of 0.2 degree within 2 minutes. The pitch attitude error was approximately 0.2 degree initially (Figure 5-11) because during the early orbits, a positive pitch disturbance torque was acting on the spacecraft thus effecting a positive pitch offset error. In later orbits, the pitch disturbance torque became negative and resulted in a small negative average pitch error. However, the direction and relative magnitudes of the error induced during the satellite night-to-day transition remained the same.

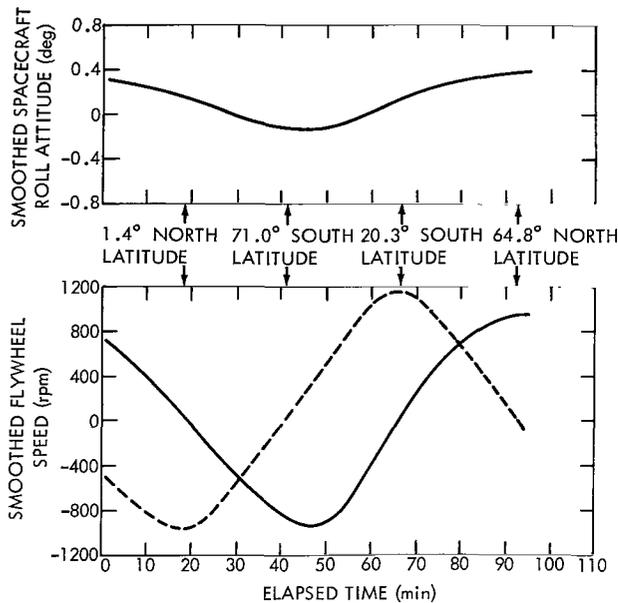
Figure 5-12—Roll-yaw momentum exchange showing induced mean roll attitude error (orbit 450).

During the Nimbus II flight there has been a continuing interchange of momentum between the roll and yaw flywheels. The spacecraft has rotated at a constant rate about the pitch axis and has completed one revolution each orbit. With no appreciable torques acting on the spacecraft, the total system momentum vector is fixed in inertial space. Therefore, the component of system momentum lying in the orbit plane must be continually interchanged between the yaw and roll flywheels. This phenomenon is shown in Figure 5-12. The interchange is brought about as the pitch

rate induces a gyroscopic moment in the yaw and/or roll flywheels proportional to their respective rotational speeds. This moment is applied to the opposite axis. For example, the yaw flywheel gyroscopic moment induces motion about the roll axis, which increases the roll attitude reference error and the roll flywheel speed. The imparted roll rate is sensed by the yaw gyro, which in turn decreases the yaw flywheel speed. This continuing effect is such that during a single orbit, the yaw and roll flywheel speeds respond in a sinusoidal manner, 90 degrees out of phase with each other (Figure 5-12). The maximum roll flywheel momentum periodically stored each orbit was greater than predicted. This increased momentum has been attributed to a disturbance torque caused by the interaction of the magnetic force field of the spacecraft.

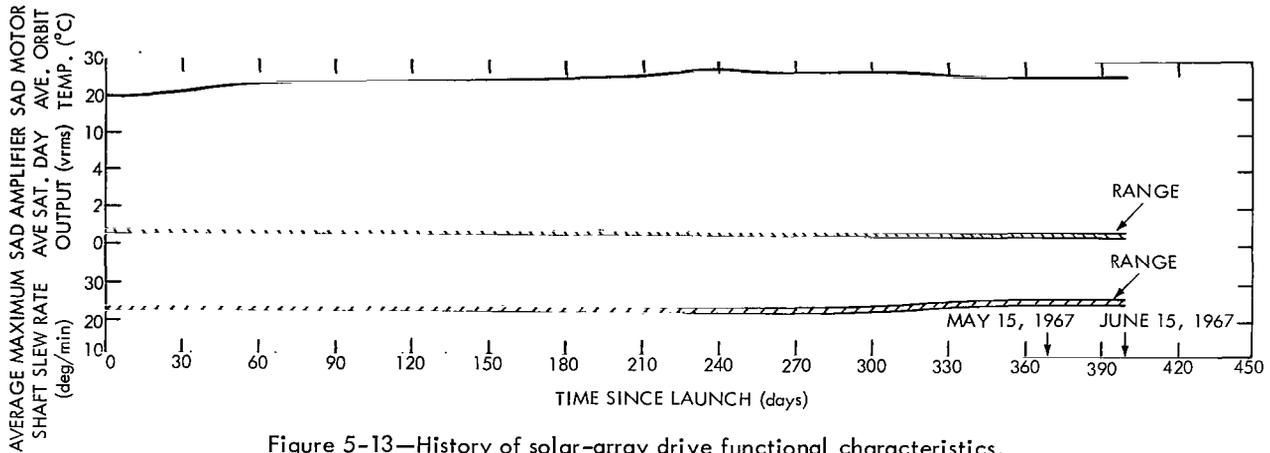
Figure 5-13—History of solar-array drive functional characteristics.

Figure 5-13 presents the history of the SAD functions. During the first month of flight, the solar array was observed to advance 0.5 to 1.0 degree after settling in its night rest position. This was attributed to noise on the 400-Hz power supply used by the SAD and flywheel motors. This phenomenon is no longer observed.

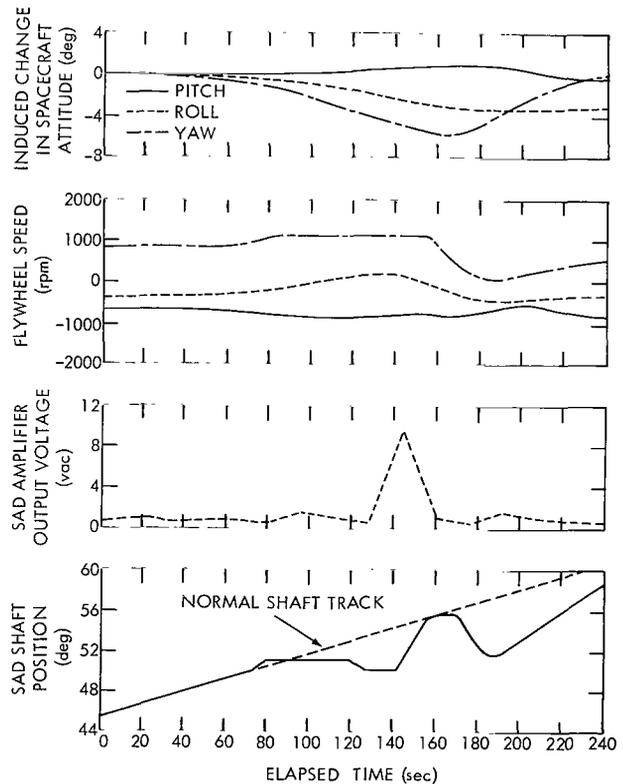
Figure 5-14—Solar-array drive reversal characteristics correlated with change in spacecraft attitude (orbit 1590).

Also, in the early parts of flight, the high solar incidence angle  $\beta$ , when combined with negative yaw error caused deviations in the SAD shaft tracking (Figure 5-14). A review of the SAD performance showed that the drive occasionally slowed down and/or reversed for 1 to 2 minutes, at which time deviations from nominal approached 5 degrees of tracking error. These deviations occurred between the earth day (0 degrees) and high noon (90 degrees) orbit position and were accompanied by large excursions of the roll and yaw flywheels because of cold cloud patterns. These deviations in shaft tracking, as noted from flight data, occurred only when the vehicle roll and yaw positions were perturbed by a cloud pattern. Therefore, it was concluded that the cause of the deviations was a negative yaw error, adding to the existing 10-degree orbit plane misalignment, resulting in uneven shading of the solar array sun sensor. This problem ceased when the  $\beta$  angle became lower. If the orbit plane solar  $\beta$  angle had become much larger, it is assumed that this anomaly would have occurred more often.

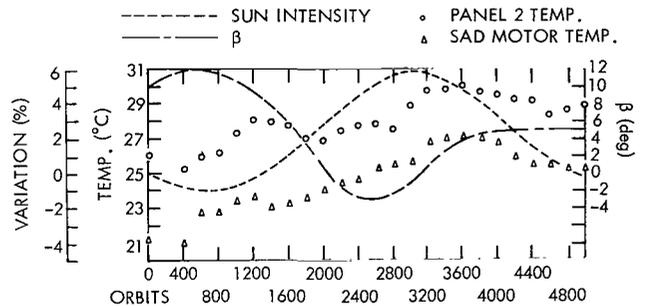
Figure 5-16—SAD motor temperature versus panel no. 2 temperature.

The SAD motor temperature has varied with the temperature of Control Housing Panel No. 2 since launch, running approximately  $3^\circ\text{C}$  lower than Panel No. 2 (Figure 5-16). Since Panel No. 2 is warmer than the SAD motor, it is assumed that the SAD motor is possibly absorbing heat from Panel No. 2 because of the thermally conductive heat path that exists between the two. In this case, the SAD motor would probably run at a lower temperature if it were not "heat-sinked" to Panel No. 2. This situation has caused no detrimental effects since the temperature of the SAD motor is well within the specified limits, averaging  $24 \pm 3^\circ\text{C}$  for the 13-month period. Since the thermistor for Panel No. 2 is located at the opposite end from the heat sink, the temperature indicated may not be

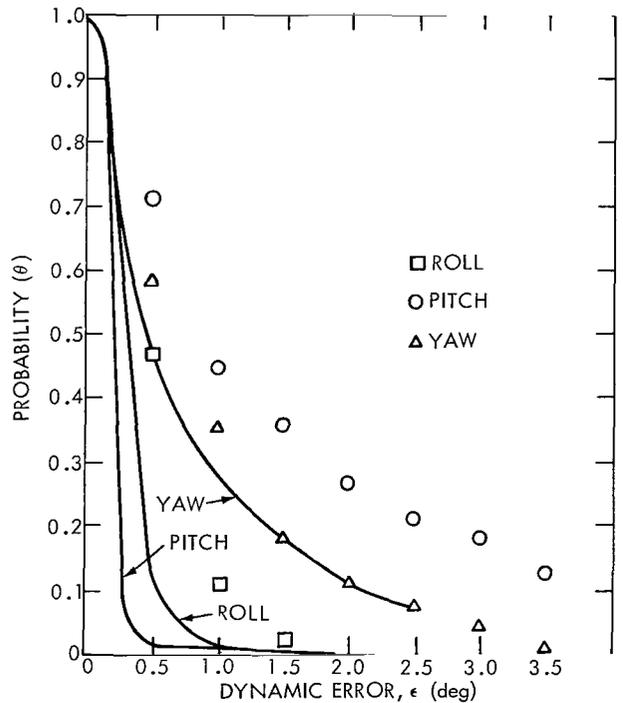
Figure 5-20—Comparison of data with independent evaluation (Reference 7).

A dynamic control system error evaluation (Reference 6), using telemetered data, was made to determine the time distribution of the pitch, roll, and yaw dynamics control system errors for the Nimbus II spacecraft. Figure 5-20 superimposes the results of an independent attitude error evaluation using a method (Reference 7) which employed a photogrammetric film reader-digitizer that could accept reduced Nimbus II AVCS frames. The figure yields good correlation for the yaw axis and reasonably good agreement for roll. The close agreement for yaw is caused by the absence of

time-base errors in the picture evaluation and the relative insensitivity to camera alignment compared to roll. Since determining the pitch attitude error from pictures requires knowledge of an exact orbit position when the picture was taken, a 1-second time error induces a 0.5-degree pitch error. This factor and potential camera misalignment are believed to be the cause of the appreciably higher pitch error variance and means shown by the picture analysis method.

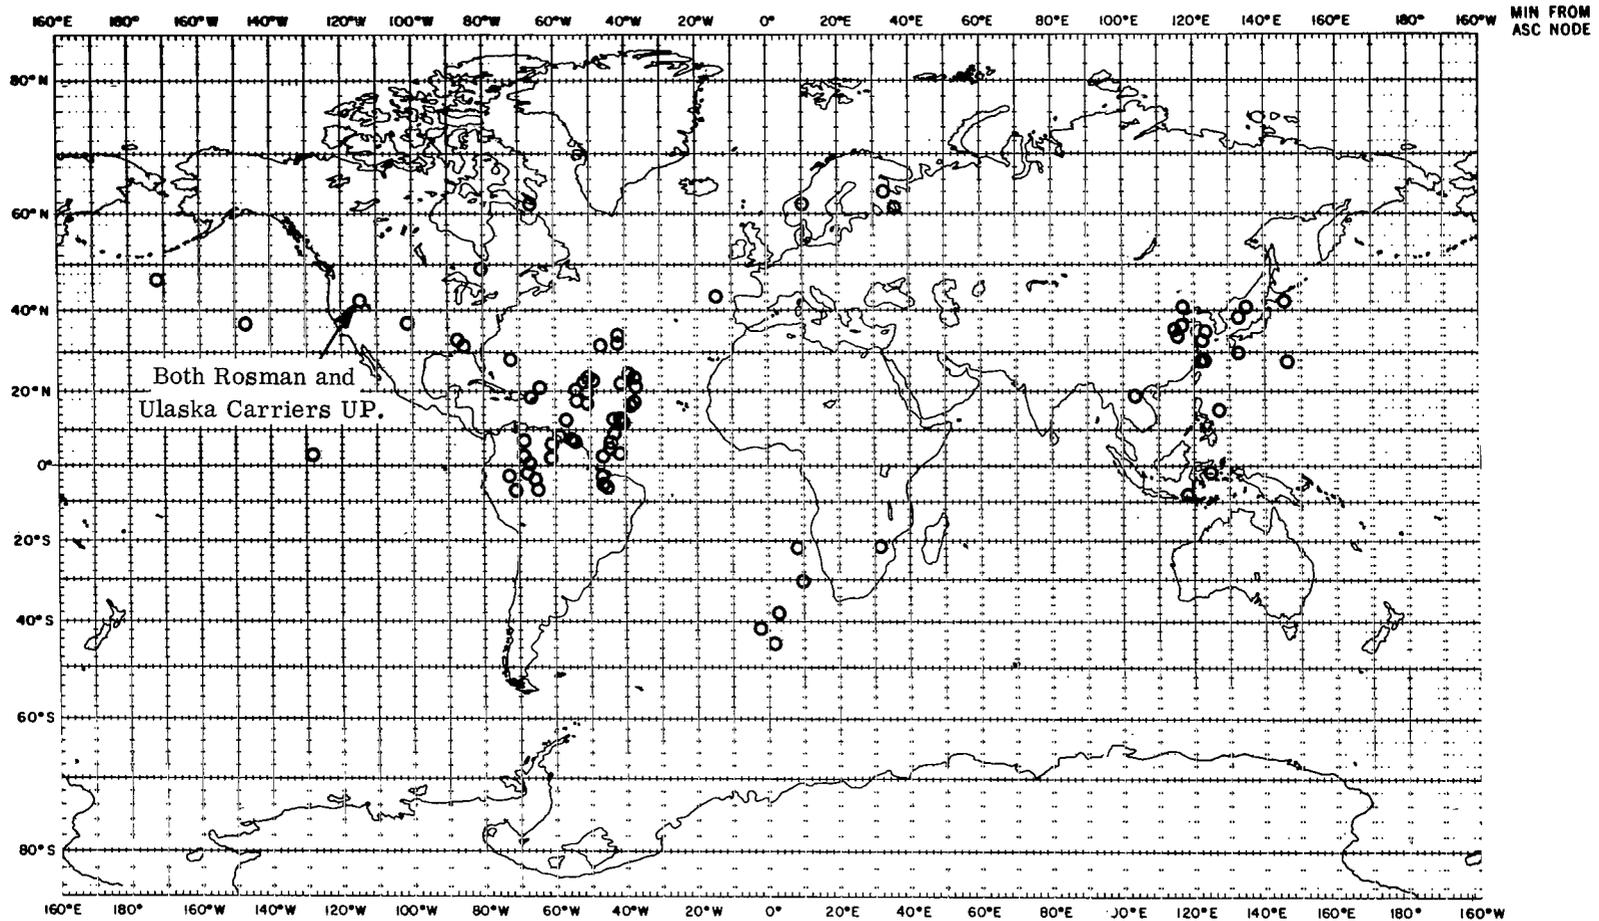
Figure 7-4—Geographic locations of unencoded command executions.

While A-stored data were available during the first 2 months of operation, a plot was maintained of the geographical locations of the unencoded command executions (Figure 7-4). Since many of these unencoded commands were executed in the general vicinity of northern South America, a standard operational procedure was developed whereby the STADAN stations at Quito, Ecuador; Santiago, Chile; and Rosman, North Carolina radiated an unmodulated carrier whenever the spacecraft was in range of these stations. There was no instance of unencoded command execution with any single station transmitting an unmodulated carrier. However, to avoid unwanted command executions caused by beat frequencies between two carriers, a 30-second interval was provided between the transmission end time for one station and the transmission start time for the next station. There were several instances of unencoded command executions during these 30-second intervals. This procedure was begun May 20 and terminated November 15, 1966. A summary of observed unencoded command execution is presented in Table 7-1.

This record may be considered incomplete because only real-time data have been available since the PCM recorder failure in orbit 949. In the last several months of operation, it has been standard procedure to command the spacecraft using the redundant FM demodulator; consequently, only U960 commands have been observed.

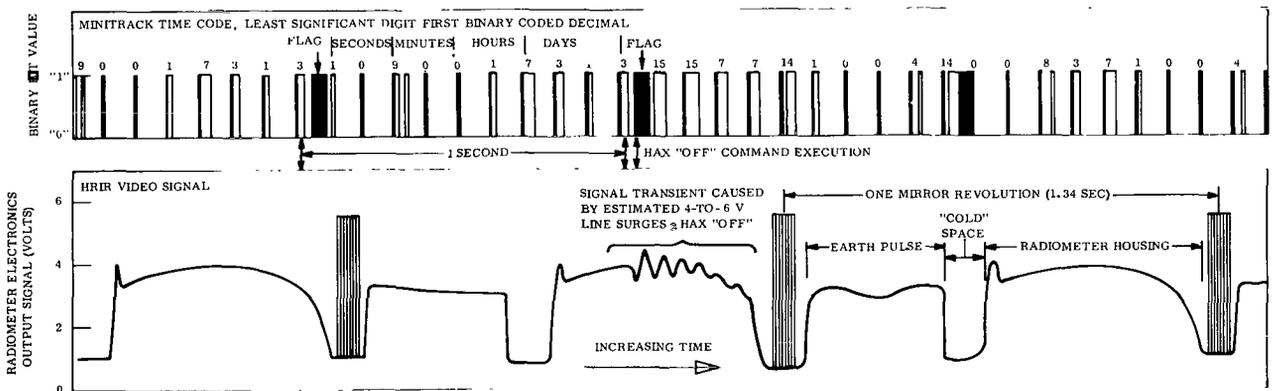
Figure 7-5—Visicorder record of HRIR video signal and minitrack time code at HAX turn-off (Ulaska-station pass orbit 28).

Another clock upset occurred during the Ulaska station pass on orbit 28. Subsequent investigation showed that the upset coincided with the time of execution of a HAX OFF command. At this time, the AVC Subsystem was ON and the S-band was warming up. A Visicorder readout of the HRIR video signal showed a 1-volt peak-to-peak transient in the 4-volt signal-level with a damped oscillation having a 60-msec period and visible for a 0.4-sec duration. The time code was disrupted, showing several "14" digits in the binary-coded-decimal (BCD) signal (Figure 7-5). An operational procedure was developed to preclude a HAX OFF switching event during S-band operation. A clock time upset also occurred during the thermal-vacuum test phase on February 19, 1966. This "upset" was also caused by execution of HAX OFF command (Reference 9).

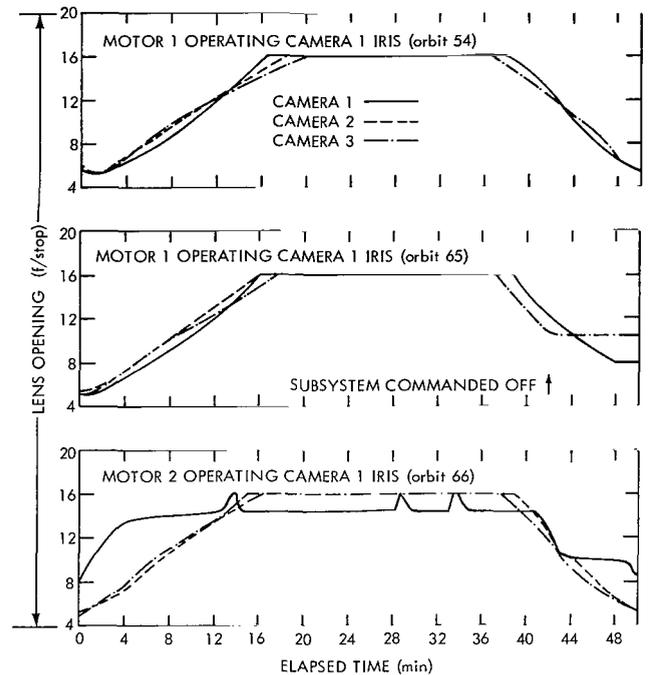
Figure 9-4—AVCS camera no. 1 IRIS drive history.

The normal practice is to alternate iris drive motors each day; however no. 2 iris motor of Camera 1 failed to position the iris properly. Telemetry indicated that the iris drive motor failed to perform properly when first activated after launch. Figure 9-4 is a comparison of the performance of the various iris motors of all three cameras. During orbits 54 and 65, the no. 1 iris motor of Camera 1 was powered; during orbit 66, the no. 2 iris motor was powered. Figure 9-4 shows that no. 2 iris motor of Camera 1 failed to maintain proper iris positioning. Since orbit 98, the no. 1 iris motor has been used exclusively for Camera 1 and has shown no evidence of performance degradation.

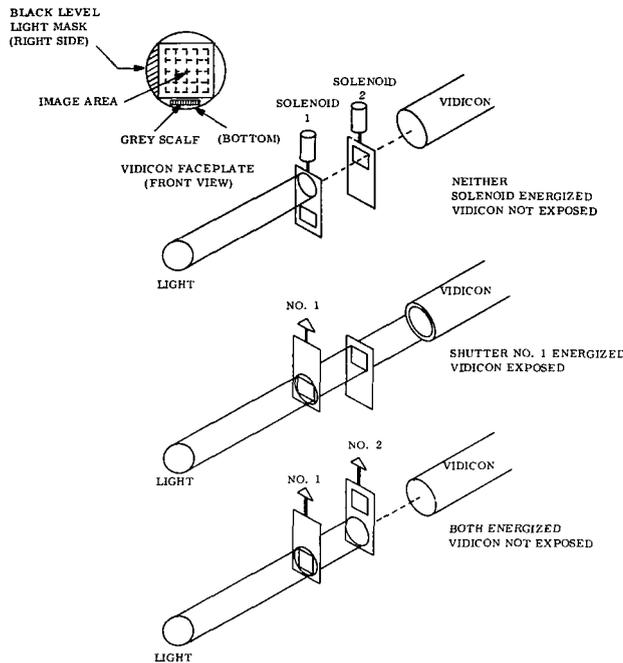
Figure 9-6—Double-bladed focal plane shutter sequence.

Each of the three AVCS cameras employs a double-bladed, focal plane shutter assembly (Figure 9-6). The blades are activated by solenoids mounted atop the camera housing energized by pulses generated by multivibrators in the camera electronics module. The blades open the shutter aperture (offset as shown in Figure 9-6) for a predetermined period of time (40 msec). The aperture in blade no. 2 is lined up with the vidicon field-of-view, while the other aperture is below the field-of-view. In this position the shutter is closed. When a pulse energizes solenoid no. 1, shutter blade no. 1 is raised, exposing the vidicon to light. Solenoid no. 2 is energized 40 milliseconds later, and raises shutter no. 2 to close the aperture. Solenoid no. 1 is deenergized 30 milliseconds later (solenoid no. 1 is therefore energized for 70 milliseconds) and solenoid no. 2 is subsequently deenergized 30 milliseconds after solenoid no. 1 is deenergized (solenoid no. 2 is therefore energized for 60 milliseconds). The vidicon is not exposed when blade no. 1 drops to the original position. Since the exposure is both initiated and terminated by raising a shutter blade, the entire vidicon faceplate is exposed uniformly. To reduce the peak current drain on the Power Subsystem, the electronic circuits that activate each camera solenoid are interconnected to provide a 70-millisecond time delay between the triggering of shutter blade no. 1 of each camera.

At the time of exposure of frame 28 in orbit 1309, shutter blade no. 1 of Camera 2 apparently failed to release at the prescribed time. The nature of the malfunction was either mechanical (binding, friction, seizure) or electrical (malfunction in the associated solenoid-enable circuitry resulting in continuous solenoid energization). This condition continued for four frames, whereupon normal operation was resumed. Movement of shutter blade no. 2 was thought to be normal, but shutter blade no. 1 did not shut as rapidly as required. This resulted in nonuniform exposure of the vidicon, the lower part of the vidicon faceplate receiving less incident light. This anomaly, seen as progressive in nature (Figure 9-5), resulted in the appearance of the reticle marks (though very faint) in the area of the first picture (frame 28) closest to the bottom of the vidicon. The bottom edge of the vidicon (Figure 9-6) contains the grey scale which, when processed, appears at the top of the processed print. Thus, the reticles on the lower part of the vidicon appear in the upper part of the processed print, and vice-versa. As time progressed, the reticle marks and grey scale vanished (frames 26 and 27). By frame 25, the reticle marks at the bottom of the vidicon were again visible. After a duration of four frames, the malfunction vanished and has not been observed since.

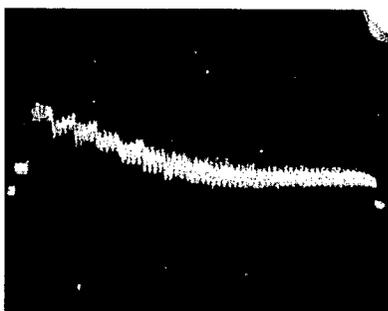
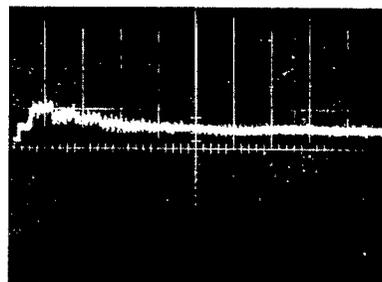
Figure 9-8—Camera 3 video displays (vertical scale: 0.5 v/cm; horizontal deflection: 5 msec/cm).

SCOPE PRESENTATION OF GREY SCALE SHOWING NORMAL  
CAMERA 3 FLASH TUBE OPERATION

SCOPE PRESENTATION OF UNDEREXPOSED GREY SCALE,  
RESULTING IN GREY SCALE OF APPROXIMATELY  
1/2-NORMAL AMPLITUDE

SCOPE PRESENTATION SHOWING ABSENCE OF  
GREY SCALE DEFLECTION

(a) ORBIT 3520, NORMAL  
FLASH TUBE OPERATION  
(2 flashes)

(c) ORBIT 3520, FLASH TUBE  
FAILS TO TRIGGER

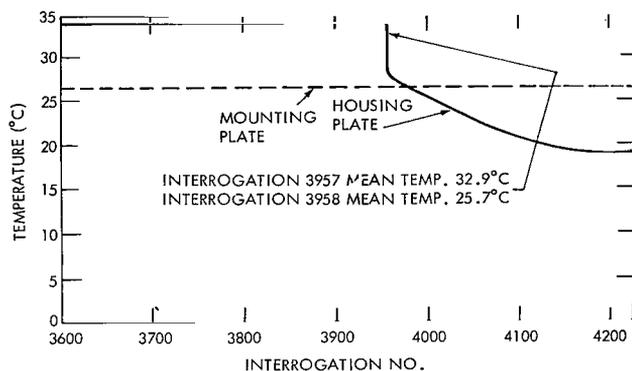
Figure 9-9—Camera 2 housing and mounting plate temperature.

irrespective of system operation. The expected temperature difference was approximately  $2^{\circ}\text{C}$  during camera operation and somewhat less than  $2^{\circ}\text{C}$  with the camera off. Hence, it was suspected that the indicated temperature of the camera was erroneous and the actual temperature was probably lower than indicated. The decrease of the telemetered temperature probably resulted from either an electrical malfunction in the telemetry conditioning circuitry or a mechanical degradation of the thermal bond between the temperature sensor and the camera housing.

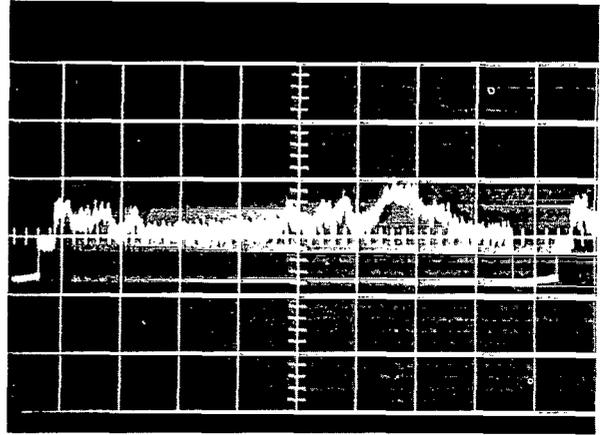
Figure 9-12—Oscilloscope display photographs of AVCS video data.

During recorder playback, prelaunch through failure, video data at times were exhibited between "triplets" because of the incomplete erasure of the recording tape (Figure 9-12). It should be noted that the quality of the received video data was not affected by this phenomenon.

(b) BETWEEN-FRAME RESIDUAL AVCS VIDEO DATA  
(note residual sync pulses)

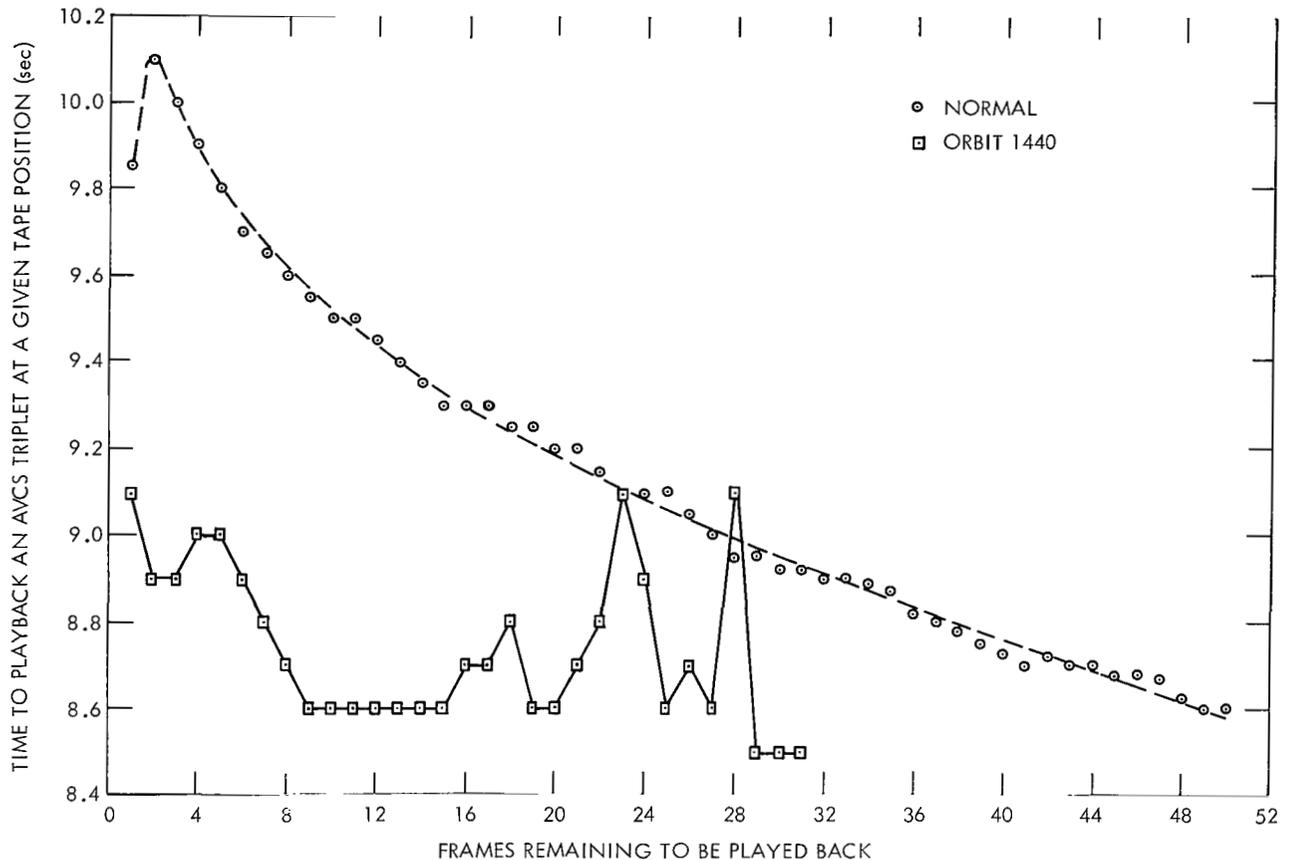
Figure 9-13—Time to play back given AVCS triplets as a function of the number of photograph frames remaining to be played back.

Information contained in the AVCS pregridding program revealed that erratic movement of the AVCS recorder tape first began during orbit 1440 and continued until the time of failure. Figure 9-13 is graphic representation of normal characteristics and the erratic characteristics first exhibited during orbit 1440. The erratic time between the reception of the video triplets and the subsequent recorder failure can probably be attributed to increased friction in the tape reel bearings, increased motor bearing friction, or a change in the characteristics of (or failure of) the negator spring.

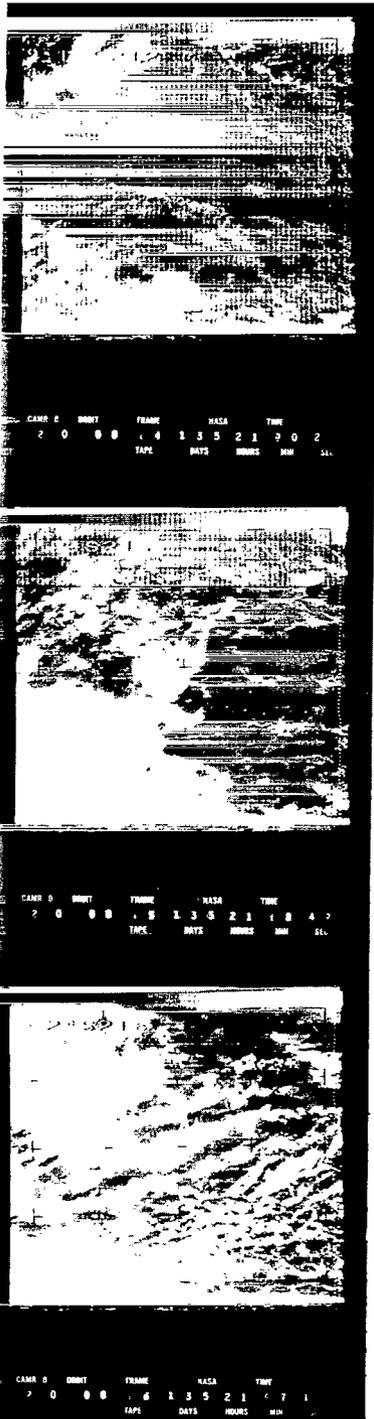
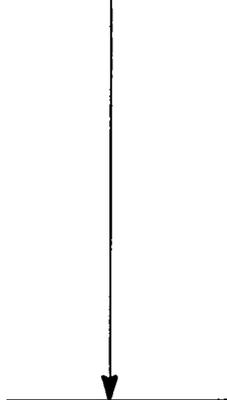
During APT Subsystem or HAX operation, the level of AVCS video shifts slightly, which makes the 10-kHz beacon interference more pronounced on the photograph (refer to Section 10). Figure 9-18 illustrates the effect of APT operation on the AVCS video.

Figure 9-18—AVCS photographs showing 10-kHz interference increasing with APT subsystem in ON mode (orbit 8U).

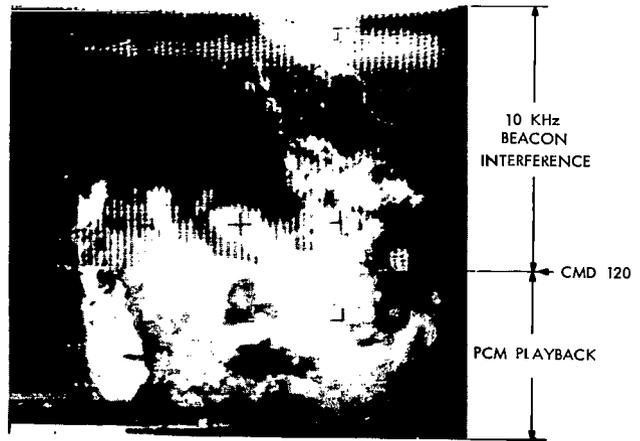
Since the failure of the PCM Subsystem tape recorder, AVCS pictures ranging from good to excellent have been obtained by commanding the PCM Subsystem tape recorder into playback. With the PCM tape recorder inoperative, there was no modulation on the beacon carrier and, therefore, neither 15-kHz nor 10-kHz interference in the pictures. Figure 9-19 illustrates this principle and is typical of the quality of the data received.

Figure 9-19—AVCS (orbit 4399) photograph showing transition from 10-kHz Beacon interference to period of interference-free data during PCM playback mode.

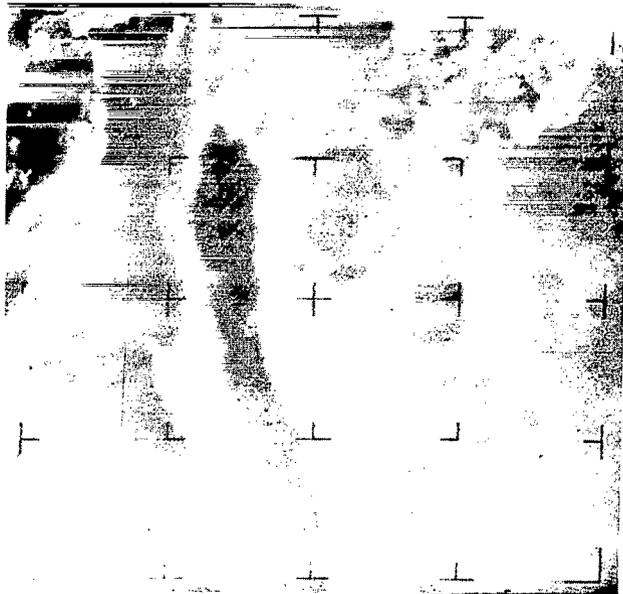
Figure 9-20—AVCS camera no. 1 photograph showing high-voltage chopper interference.

On occasions, faint AVCS chopper interference of approximately 3.3 kHz was present in the video of Camera 1 only (Figures 9-11 and 9-20). The origin of this interference is the high-voltage converter circuitry in the AVCS camera electronics. This type of interference was rather rare and did not seriously degrade the overall video quality.

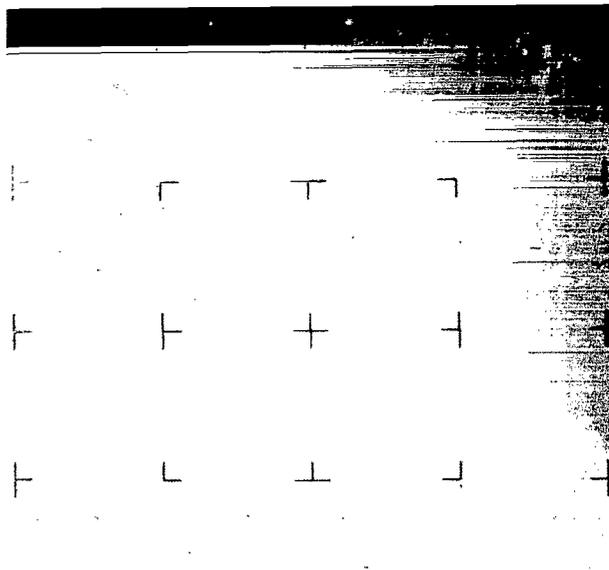
The APT Subsystem camera shutter was triggered immediately following separation by a voltage transient, recording a picture of the adapter and the forward bulkhead of the Agena (Figure 10-3).

Figure 10-3—APT photograph of Nimbus II adapter 2.2 seconds after separation. (Circular adapter is seen as "shadow" in center of photograph.)

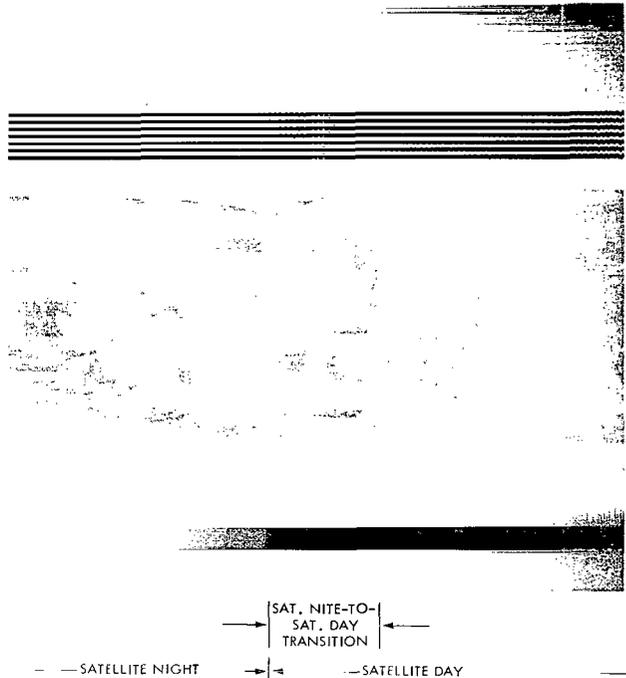
Figure 10-4—HRIR-HAX photograph of hurricane Alma (June 6, 1966) showing sunlight input at transition from satellite day to satellite night.

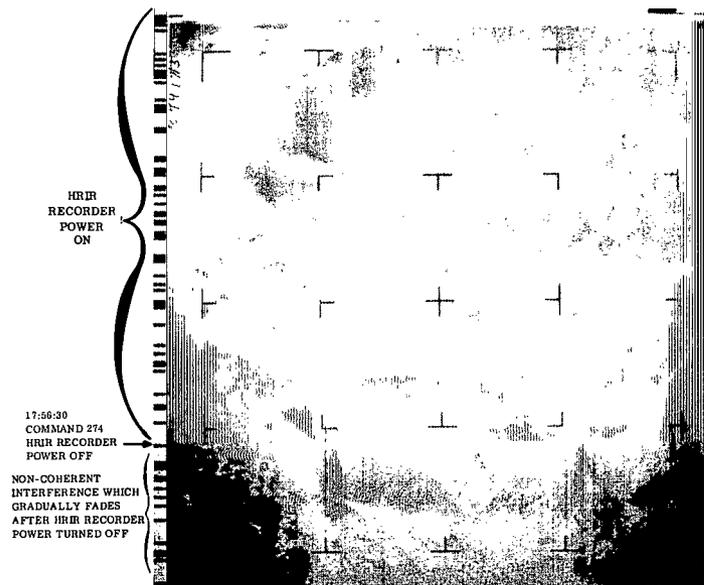
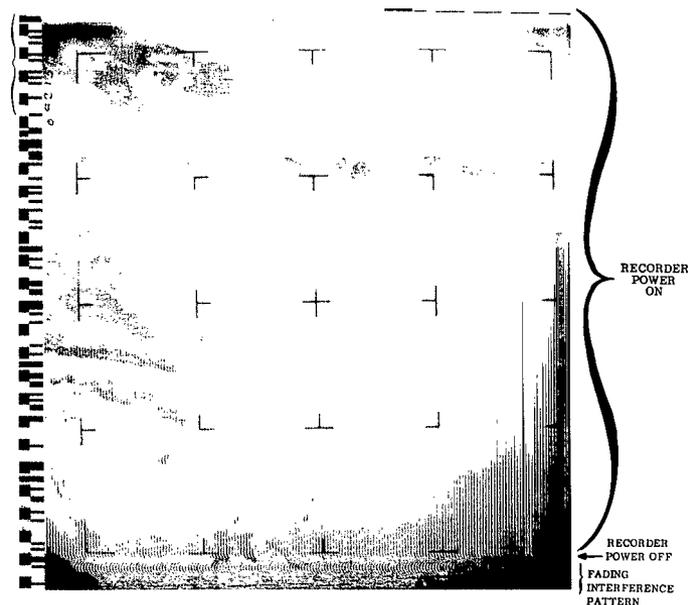
Interference has occurred occasionally when the HRIR recorder was powered in the playback mode (Figure 10-7). A similar interference occurred during prelaunch testing (Figure 10-8 and References 10 through 13). The interference varied between 0.8 kHz and 1 kHz and showed the characteristic of "fading" after removal of the HRIR recorder power. The varying frequency and the fading characteristic of this interference suggest that the interference is of a mechanical nature (vibration) induced by the operation of the HRIR recorder, which has sufficient magnitude and frequency to induce resonant vibrations of the APT vidicon internal elements during the time the APT Subsystem is reading out a picture. The APT vidicon and the HRIR recorder are mechanically mounted in close proximity on the H-frame structure of the spacecraft, and the HRIR recorder motor utilizes a 400-Hz signal as a drive source. Therefore, the interference most probably resulted from the second-order harmonic of the HRIR recorder power.

Upon removal of HRIR recorder power, the interference becomes noncoherent and fades out as the vibrations dissipate. This type of interference can seriously impede the usefulness of the APT photographs. However, since this interference is present only during that time the HRIR recorder is powered, less than 4 percent of the pictures are affected. This interference should not be confused with the microphonic interference between 0.7 and 0.9 kHz, which appears randomly at the top end of the photographs (that portion of the photograph immediately following the 300-Hz start tone and phasing portion; see Figures 10-6 and 10-7).

MICROPHONICS INTERFERENCE  
-0.9 kHz  
(NOT ASSOCIATED WITH HRIR RECORDER ON INTERFERENCE)

Figure 10-7—APT subsystem photographs showing fading effect of HRIR interference when power is removed from HRIR recorder.

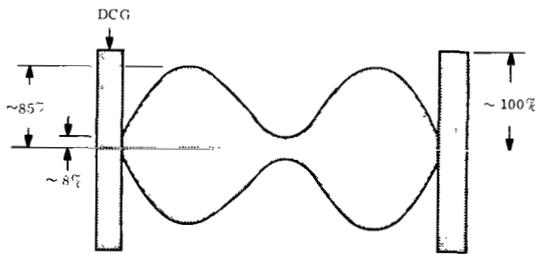
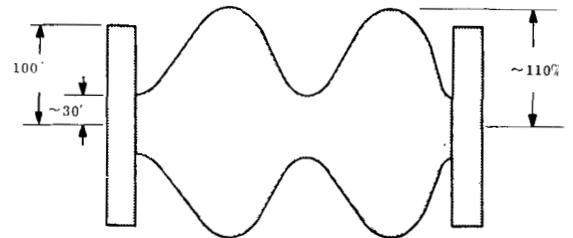
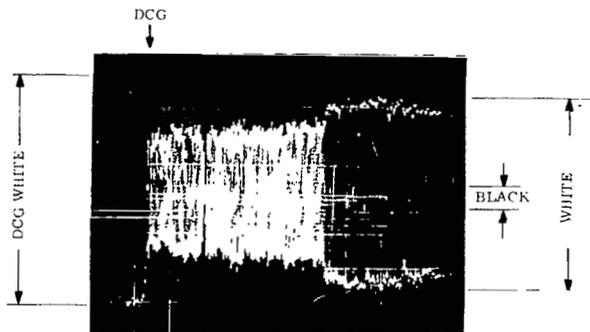
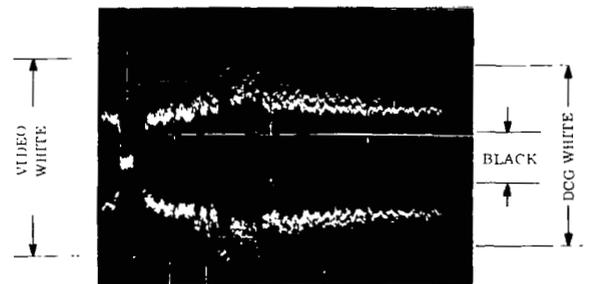
The characteristics of the APT amplitude modulation (Figure 10-9) reflect a gradual dc level shift in the video during the second 6-month period of flight. Before the level change, black-signal input drove the modulated video to approximately 8 percent of the white DCG level and, with a white input, approximately 85 percent of the white DCG level. Currently, the black modulates the video to approximately 30 percent of the dc white level, and white to approximately 110 percent of the DCG white level. Graphic presentation of this phenomenon (Figure 10-10) indicates the occurrence of a dc shift of the video toward white. Fortunately, compensation for the level change can be made within the ground station processing equipment either by

INITIAL POST-LAUNCH MODULATION LEVEL REPRESENTATION IN WHICH PEAK VIDEO WHITE LEVEL WAS  $\sim 85\%$  OF WHITE DCG LEVEL AND BLACK  $\sim 8\%$  OF WHITE DCG LEVEL.

CURRENT MODULATION LEVEL REPRESENTATION IN WHICH PEAK VIDEO WHITE LEVEL IS  $\sim 110\%$  OF WHITE DCG LEVEL AND BLACK  $\sim 30\%$  OF WHITE DCG LEVEL.

Figure 10-9—Comparison of APT subsystem video characteristics. (Oscilloscope photographs showing test-launch and late orbit characteristics.)

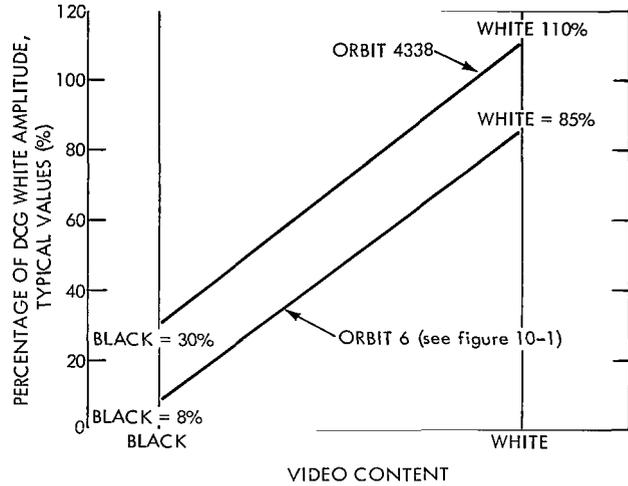
Figure 10-10—APT subsystem signal-level shift.
