# NIMBUS II FLIGHT EVALUATION AND ENGINEERING REPORT, LAUNCH THROUGH ORBIT 5275

NIMBUS II FLIGHT EVALUATION AND  
ENGINEERING REPORT,  
LAUNCH THROUGH ORBIT 5275

By Joseph J. McNaney and Bennie A. Palmer  
General Electric Company

Ralph Shapiro  
Goddard Space Flight Center  
Greenbelt, Md.

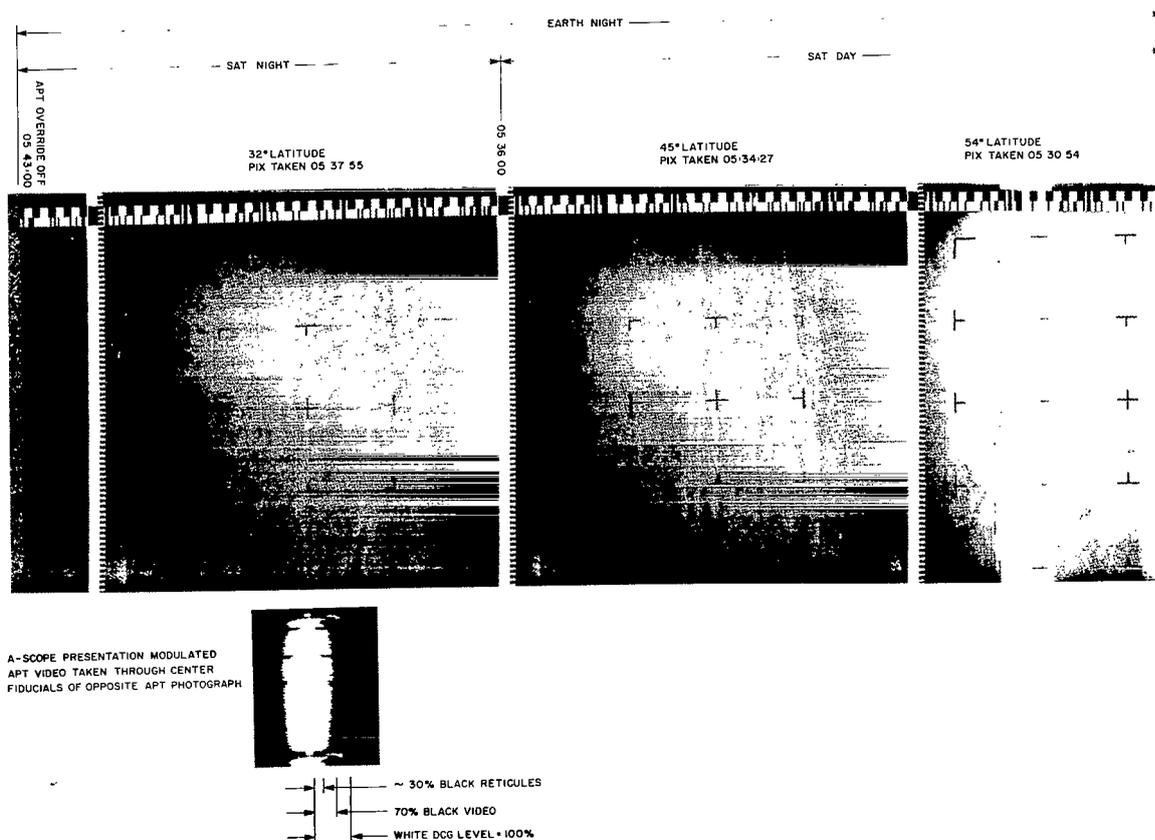
Alteration of the processor transfer characteristics enabled the production of the photograph shown in Figure 10-12 as further verification of the level change. Measurements were made of the "black" video level utilizing night photography during orbit 4898 (Figure 10-13).

Figure 10-13--APT subsystem night photographic sequence (interrogation 4898R).

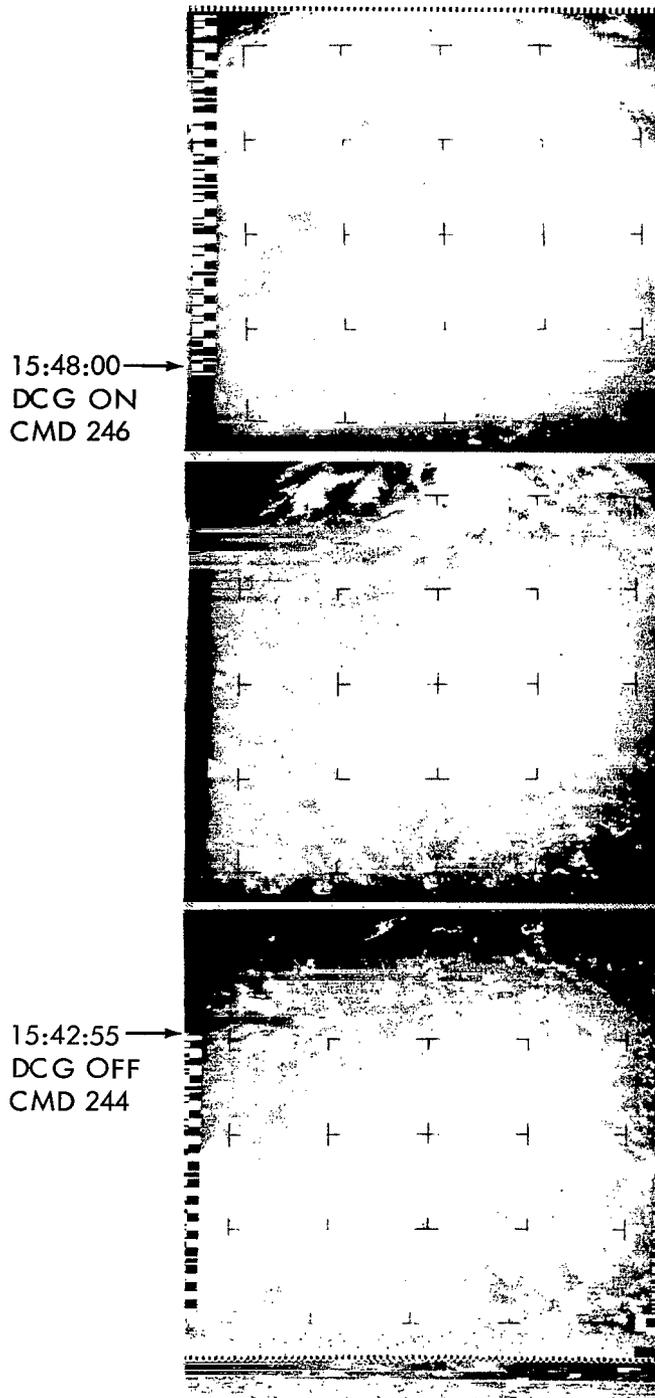
and video) establishes the dc bias for the foregoing functions for the driver of the video modulation. In an attempt to isolate the origin at the dc level shift, the DCG was commanded off for a short period during interrogation 4864 at Rosman (Figure 10-14). The modulation characteristics of the APT video remained unchanged during this period, thus eliminating the DCG portion of the video switching circuitry, the source of the malfunction. The contrast (dynamic range) of the video was not significantly degraded; only a dc level change of the video occurred.

Figure 10-14—APT subsystem photographic sequence during which data code and grid was commanded OFF/ON (interrogation 4864R).

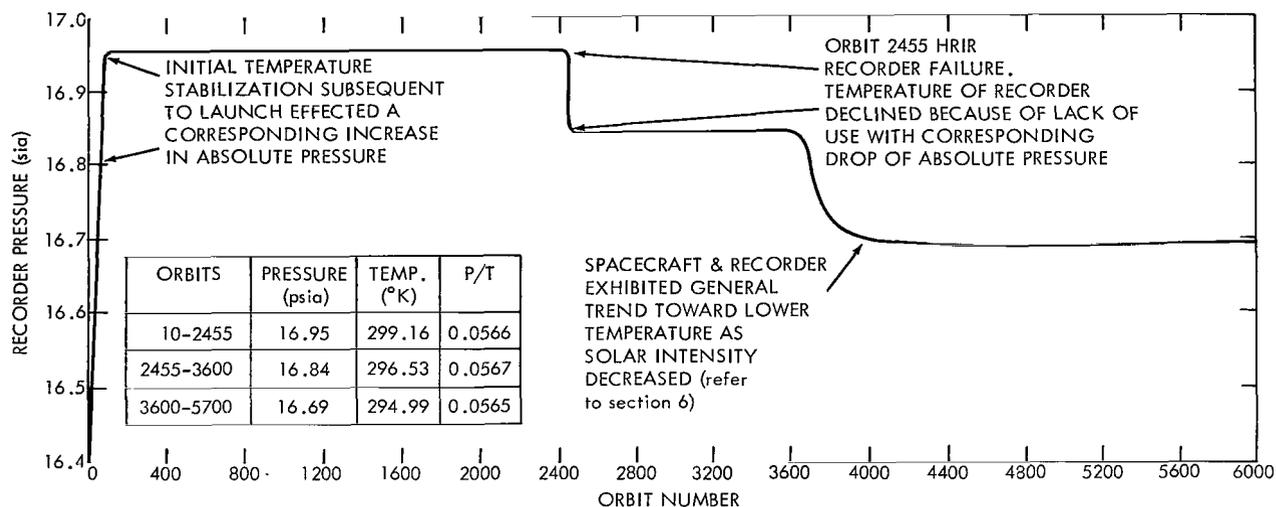
The pressure of the subsystem recorder versus time in orbit is presented graphically in Figure 11-4. The pressure-temperature relationship has followed the universal gas law and has shown no evidence of long-term pressure degradation.

Figure 11-4—HRIR pressure versus time in orbit.

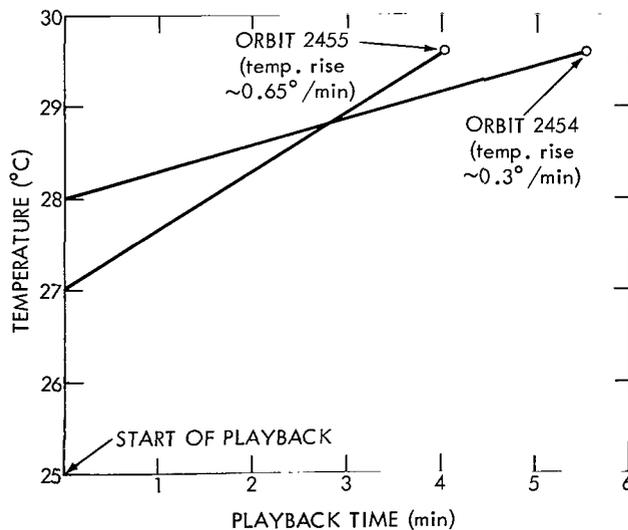
- The HRIR Subsystem, including the tape recorder, remained in the playback mode.
- Video and timing were not present at either the output of the playback amplifiers or in the composite signal input to the S-band transmitter.
- The recorder's power inverter exhibited an abnormally high temperature increase at the time of failure. This could have resulted from a higher current drain by the motor when it stalled (Figure 11-5).

Figure 11-5—Correlation of inverter temperature during normal and failure playback.

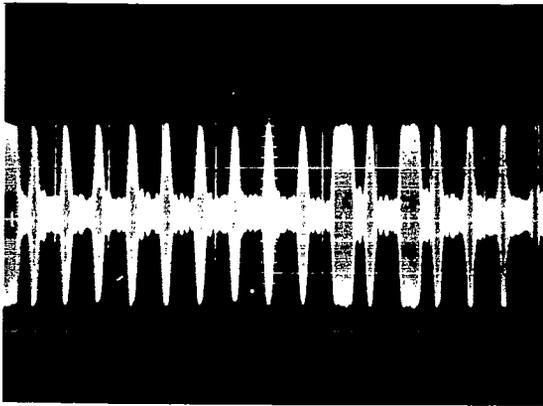
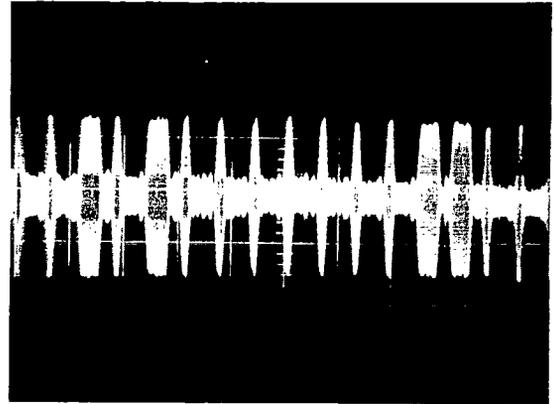
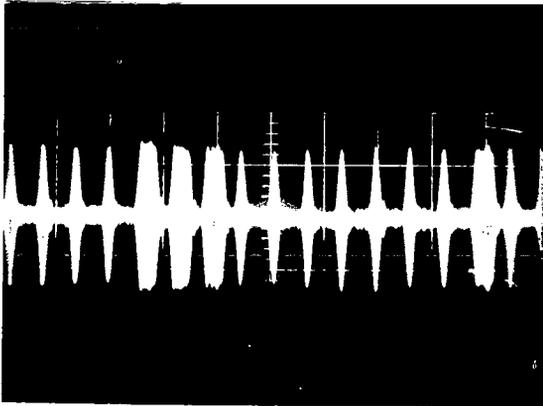
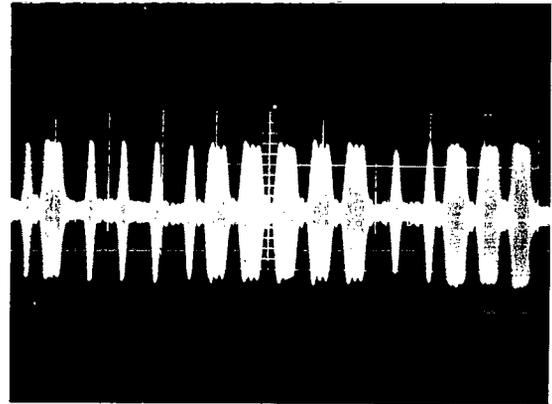
Before the failure of the subsystem recorder, clockwise\* HRIR timing had consistently exhibited a 25 percent decrease in amplitude during the last 220 seconds of counter-clockwise playback and, correspondingly, during the first 220 seconds of clockwise playback (Figure 11-7). A sharp increase in recorder flutter and wow accompanied the decrease in time code. The amplitude of the counter-clockwise HRIR timing exhibited a 15 percent decrease in amplitude during this period. The length of tape affected did not increase; however, the magnitude of the degradation over the affected area slowly increased. Figure 11-8 is a typical flutter and wow strip recording showing the transition between the affected and nonaffected areas of the tape. This was probably caused by a degradation of the tape which resulted in improper tape tracking. Such degradation may have been in the form of ribboning, nonuniform stretching, or wrinkling of the tape area in question. This anomaly did not affect the quality of the stored video data.

Figure 11-7—HRIR subsystem timing amplitude degradation.

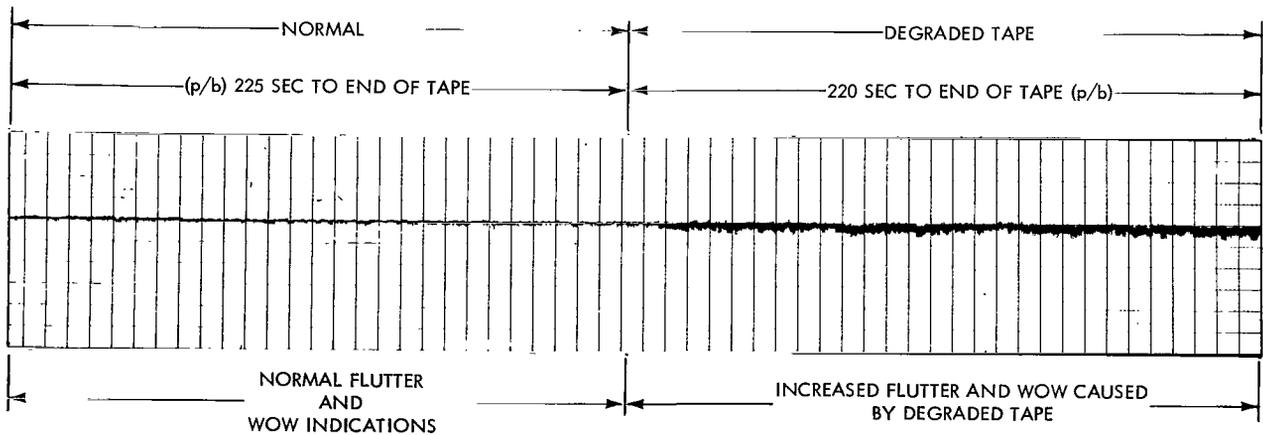
The last 220 seconds of counter-clockwise playback (discussed under Timing Amplitude Variations) were accompanied by sharp increases in recorder flutter and wow. The failure in playback occurred in this degraded region at approximately 99 playback seconds from the end of the tape; the record failure also occurred in this region at approximately 162 playback seconds from the end of the tape.

Figure 11-8—Typical flutter and wow strip recording showing transition between degraded and normal conditions.

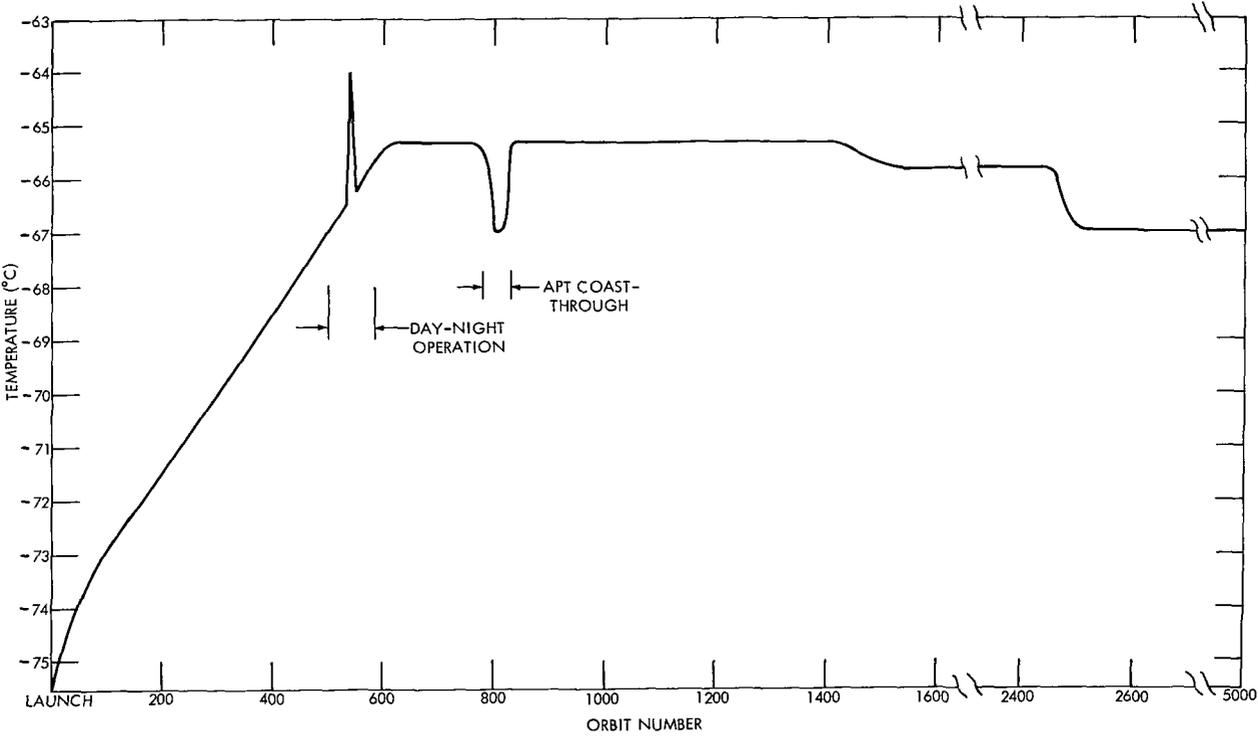
time in orbit-versus-temperature profile of the detector cell is presented in Figure 11-9. Before the failure of the subsystem recorder, the detector cell temperature orbital profile had been  $-65.6 \pm 1^\circ\text{C}$ , and data of excellent quality were received. After the recorder failure, a decrease of the orbital temperature profile to  $-67 \pm 0.5^\circ\text{C}$  resulted since the radiometer electronics were no longer powered. Continuous day and night subsystem operation was attempted, but a general overheating of the subsystem components necessitated the return to nighttime operation only. The additional thermal loading caused detector cell temperature to increase to  $-64.0^\circ\text{C}$ .

The elevated detector cell temperature can be attributed to distortion of the inside surface of the cooling cone at the outboard edge, flaking and/or outgassing of the black coating from the cooling patch, or improper operation of the active temperature control loop of the detector cell. Cooling cone distortion results from the high temperature produced by incident solar energy. Such distortion could not only change the cooling characteristics of the cone but could permit solar energy to be reflected to the cooling patch located at the cone apex. The flaked coating particles adhering to the cone gold surface could have changed the cone's thermal characteristics as well as those of the cooling patch itself.

of  $67 \pm 0.5^\circ\text{C}$ . Although laboratory tests have failed to duplicate this problem, it is presently believed that the most probable cause of the overheating of the detector cell is flaking or outgassing of the cooling patch black coating.

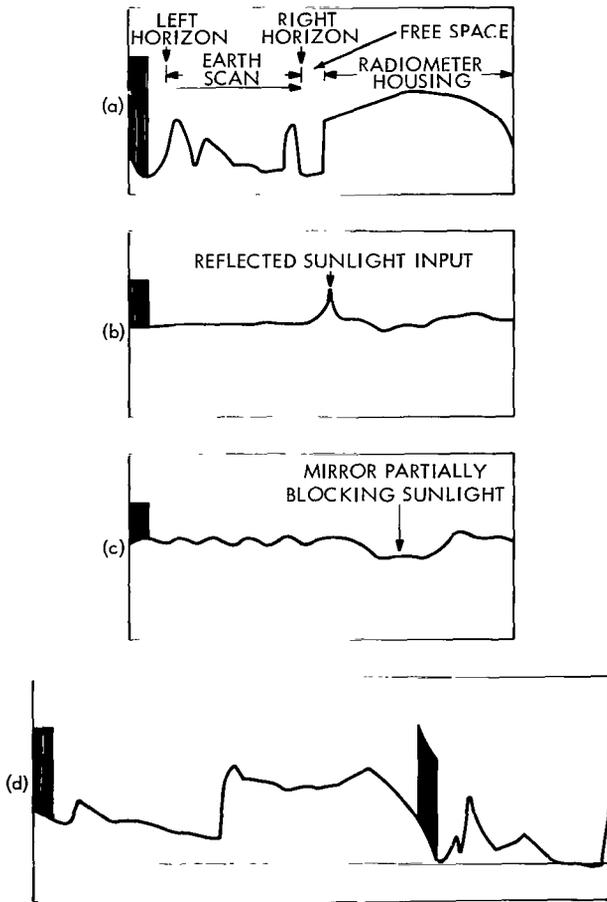
The mirror-shield portion of the Nimbus II HRIR radiometer housing (Figure 11-2) was designed to prevent incident solar radiation from entering the radiometer, assuming normal spacecraft altitudes, at a mean orbital altitude of 500 nautical miles. In the 600-nm orbit which Nimbus II attained, direct sunlight enters the detector cell at the satellite night/day transition and raises the entire video level to almost the same height as the sync pulses. Figure 11-10 shows a normal line of HRIR video (Figure 11-10a) becoming obliterated by direct sunlight entering the radiometer (Figure 11-10b). The mirror, in scanning the radiometer housing receives additional sunlight reflected from the housing. As the spacecraft proceeds, more light enters directly. The reflection

ceases, and the mirror, in scanning the radiometer housing, blocks input sunlight (Figure 11-10c). Later the radiometer housing blocks out the remaining sunlight, and the slow time constant of the bias circuit allows the signal to become slightly negative (Figure 11-10d). Sunlight obliterates all video information for approximately 1-1/2 to 2 minutes. During the period of sunlight interference, the HRIR bias circuit functions properly, slowly reducing the bias bulb voltage in proportion to video signal amplitude. Thus overall video amplitude decreases slowly. As the sunlight is blocked by the radiometer housing, the video output decreases below its pre-interference level, because of the lower bias bulb voltage (Figure 11-11). This allows the video signal to reach

Figure 11-10—HRIR sunlight interference during satellite night/day period.

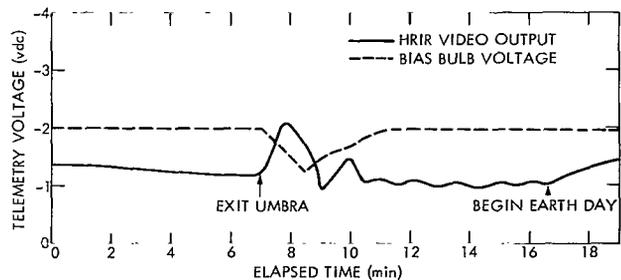
Figure 11-11—Sunlight input effects shown on HRIR telemetry.

negative levels, the condition for which the bias bulb was installed to prevent underexpected conditions. At the satellite day/night transition, sunlight is reflected from the radiometer housing into the detector cell. This is of much lower intensity than the direct sunlight at the satellite night/day transition and merely degrades video slightly for approximately 2 minutes (Figures 11-12 and 11-13).
